Experimental Simulation of Damage in Spatial Filter Lenses

Abbey Rhode, Jason Taniguchi

Laboratory for Laser Energetics, University of Rochester
250 East River Road, Rochester, NY 14623-1299

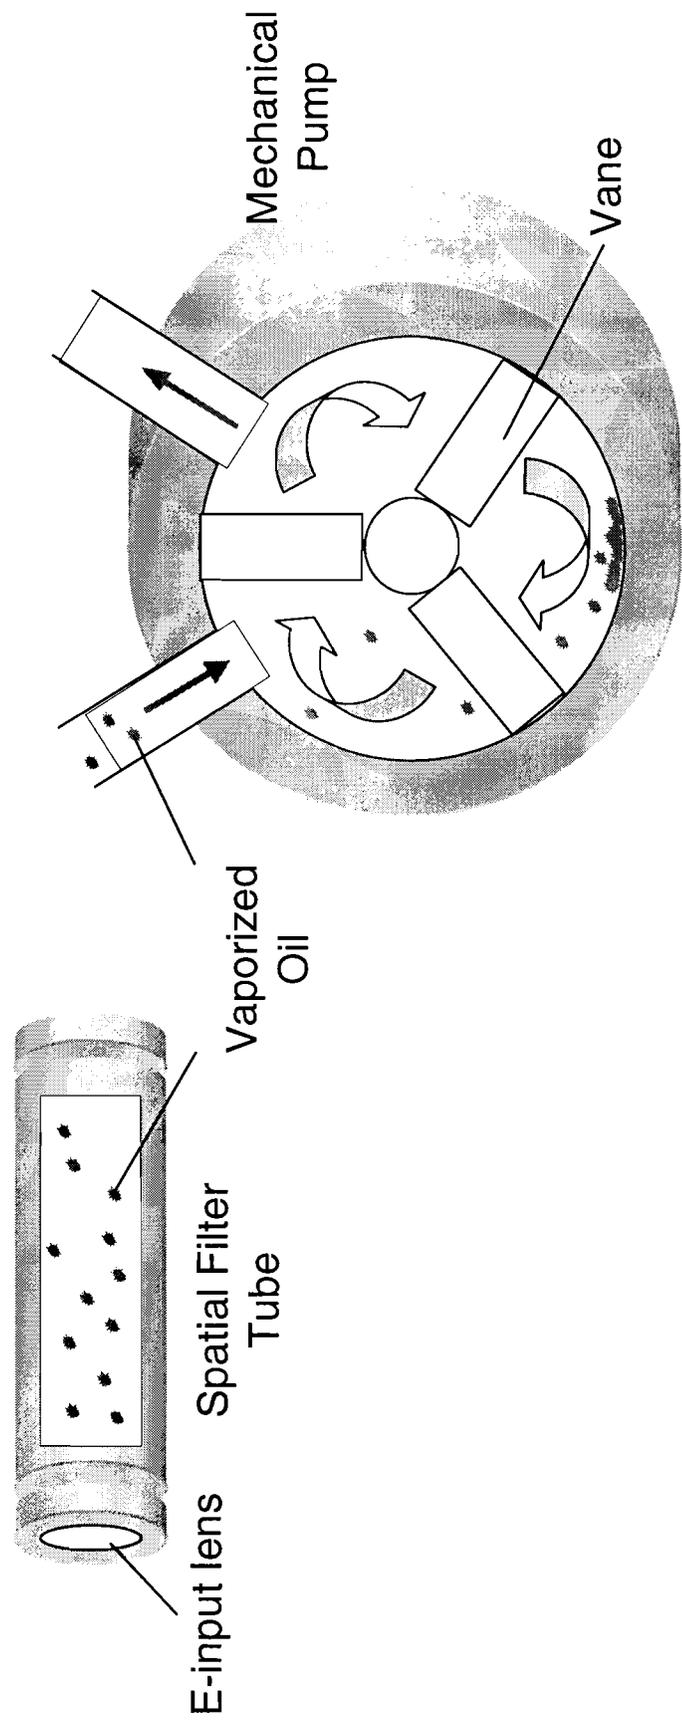
Fig B.

Spatial filter lenses on the OMEGA laser system require regular replacement due to bulk damage in the optics (see figure A). It is believed that this behavior is caused by oil vapor contamination of the spatial filter tubes. This vapor originates in mechanical vacuum pumps used to create a vacuum inside the tubes (see figure B). If left unchecked,

Diagram of Mechanical pump and spatial filter tube contamination

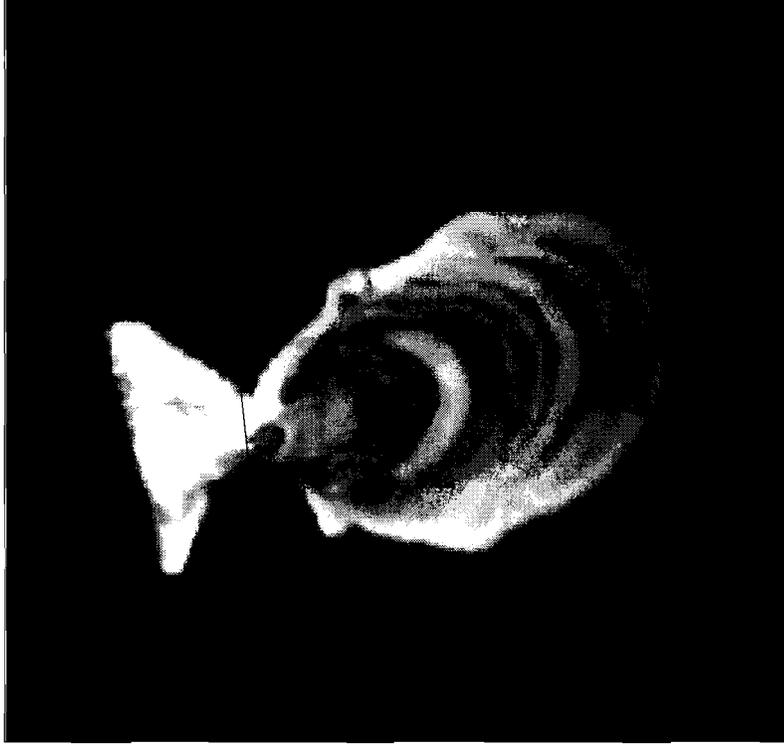
Fig C.

In the sol-gel coated lenses, a defect type known as clamshells have formed. These defects, which appear as slits on the surface, actually extend deep into the optic (see figure C). It is believed that tiny microscopic cracks in the optic (which have been observed in the past as a result of lens processing methods), when mounted on a spatial filter tube, are spread open on the vacuum surface due to bending stresses caused by the vacuum inside the tube. When the sol-gel then absorbs oil vapor, the contamination reaches into these cracks. When irradiated by laser light the oil burns and causes the clamshell defect to form. This theory is supported by a carbon residue found in the clamshell sites. A defect such as a clamshell has been shown to grow into larger damage sites when irradiated by laser light, similar to the kind found on damaged spatial filter

Clamshell defect found on Sol-Gel lens
