**Investigating the Causes of and Possible Remedies for Sensor Damage in Digital Cameras  
Used on the OMEGA Laser Systems**

Krysta Boccuzzi

**Our Lady of Mercy High School**  
Rochester, NY

**Laboratory for Laser Energetics**  
University of Rochester  
Rochester, NY

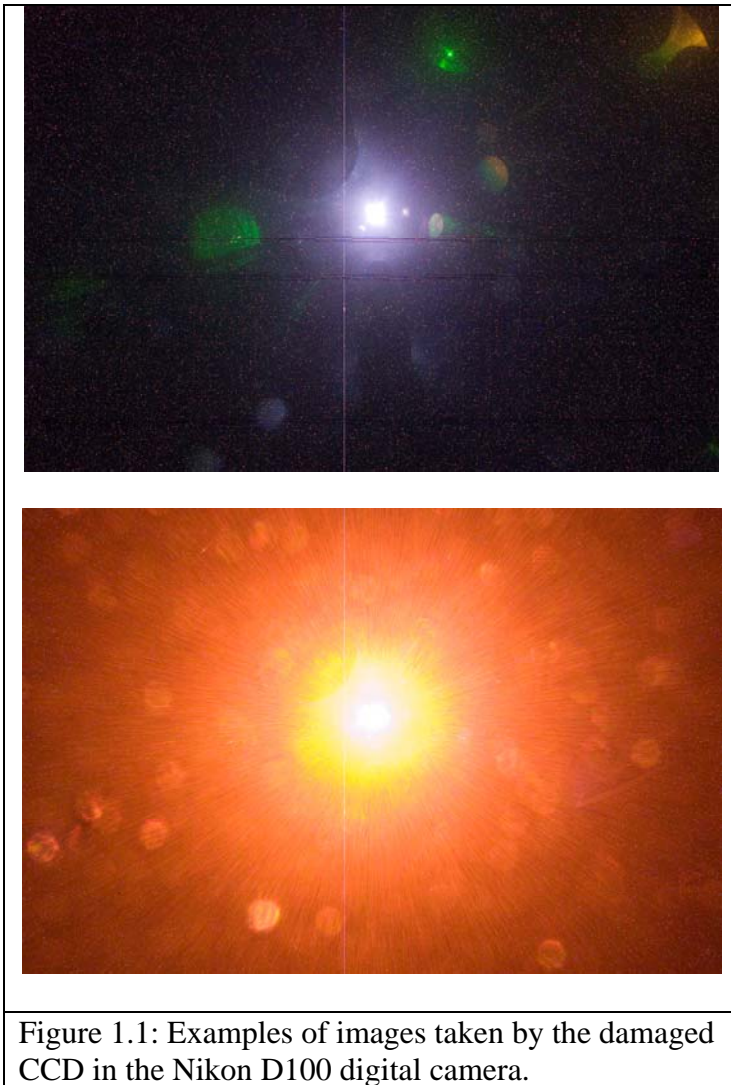
Figure 1.1: Examples of images taken by the damaged CCD in the Nikon D100 digital camera.

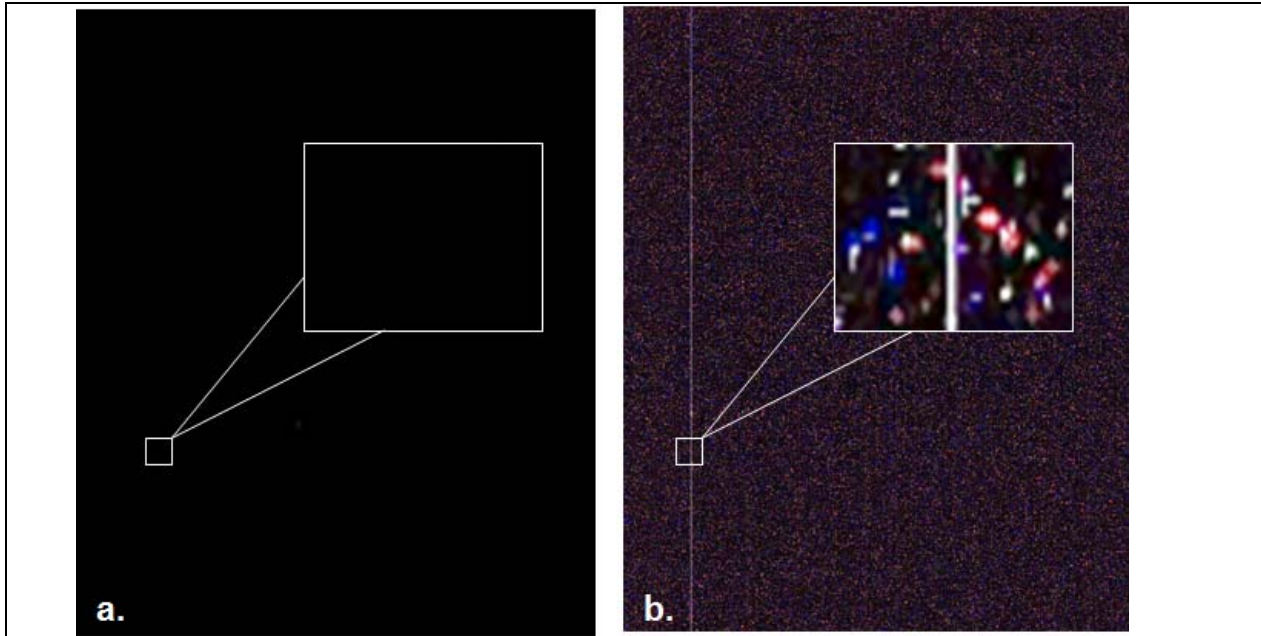
The damage appears in the image as hot pixels, stuck pixels, and noise, as can be seen in figure 1.2(b). Hot pixels are permanently lit pixels that appear white and can lead to line defects, such as the vertical white line seen in figure 1.2(b). In a CCD, the charge from each pixel travels down a vertical line of pixels in order to reach the output node. If one of the pixels in this line has a defect, it can not correctly transfer the electrons to the output node, leading to a line defect. Stuck pixels occur when one or more sub pixels are permanently either lit or unlit, causing the pixels to always appear red, blue, or green. This can explain the many red and blue spots in the blank shot from figure 1.2(b). Noise is a statistical variation that can appear as monochromatic grain or colored waves. Figure 1.3 gives histograms of the red, green, and blue pixels

Figure 1.2: (a.) A blank shot taken with the D100 before being placed outside the target chamber  
 (b.) A blank shot taken with the D100 after 13 months outside the target chamber

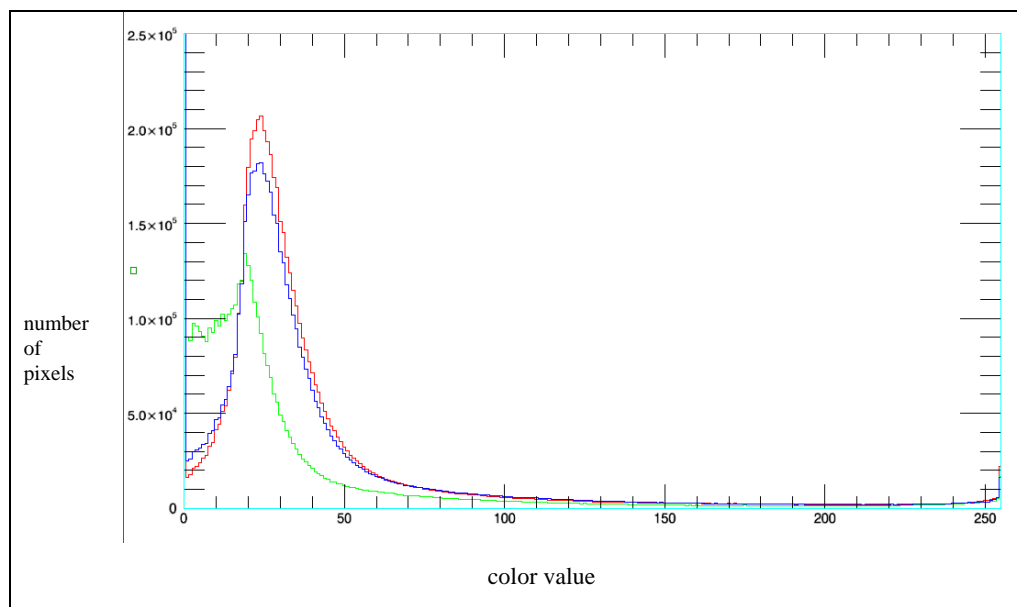
in the image in figure 1.2(b) and indicates the presence of dark current, which occurs when a pixel is charged even though there is no incident light to produce a charge in that pixel. A histogram of a blank shot should show that the red, green, and blue color values for all the pixels are 0. However, the

histogram of figure 1.2(b) shows that these color values vary between 0 and 255, indicating that the pixels are producing a charge when there is none.

Figure 1.3: Histograms of red, green, and blue pixels corresponding to the image in figure 1.2(b)

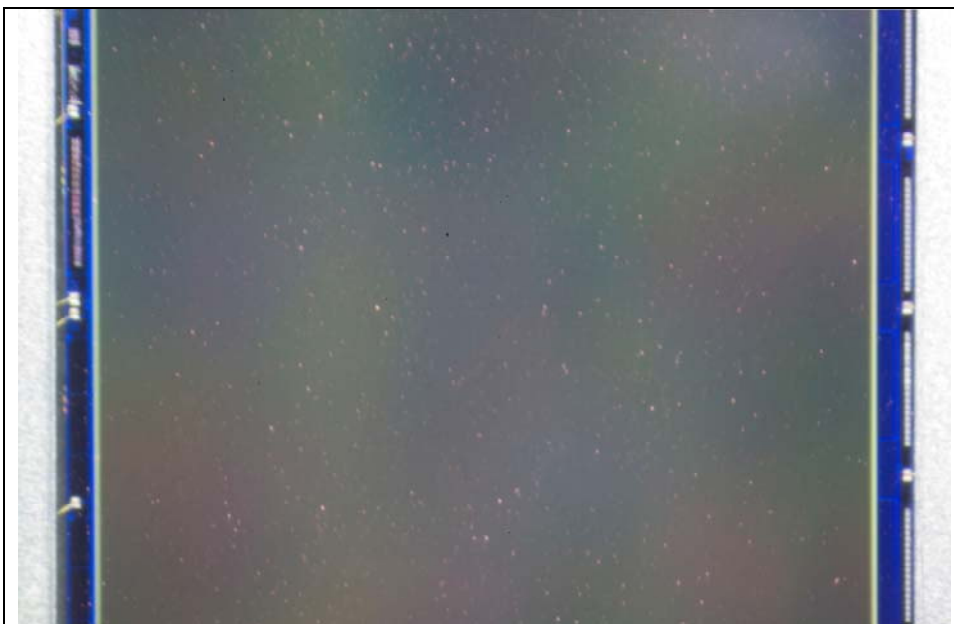
The damage can be seen not only on the images but also on the CCD sensor. When the imager was examined under a stereo microscope, many small white spots could be seen around the surface of the device, as can be seen in figure 2.2. These spots could be the result of the device being pelted with

Figure 2.2: A 12.1 mm long and 15.6 mm wide (1536 by 2000 pixels) section of the damaged CCD taken from the Nikon D100

high energy particles, such as neutrons.

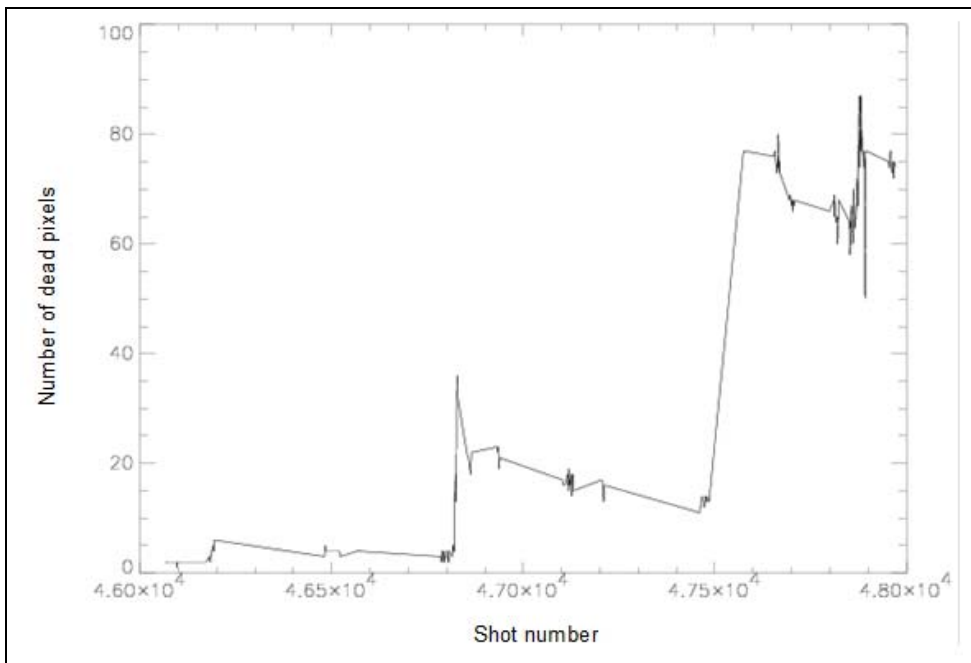
NTD includes a streak camera that utilizes a CCD and gathers information about the neutron burn history.<sup>4</sup> The CCD sensor used on the NTD showed significant damage, mainly in the form of dead pixels, or pixels that are permanently unlit and appear black. Analysis of images from the streak camera includes the implementation of an algorithm that calculates the number of dead pixels in that image, among other calculations. The graph in figure 2.3 shows the progression of the amount of dead pixels over a time period of 6 months. The graph contains 157 data points, beginning at shot 46068, when the current CCD was first used, and ending at shot 47970. In this time period, the two most noticeable spikes include a rise from 13 dead pixels in the image from shot 46825 to 36 dead pixels from shot 46827 and an increase from 13 dead pixels in the data from shot 47485 to 77 dead pixels from shot 47575. Both spikes correspond to shots with high neutron yields. The graph shows some

Figure 2.3: A graph representing the progression of damage to the CCD in the Neutron Temporal Diagnostic. Noticeable spikes correspond to high neutron yield shots

decrease in dead pixels over time, as it is possible for dead pixels to resurrect.

With current technology, it is difficult to find an effective method of protecting CCD sensors from radiation damage. However, shielding can increase the life of the device. For example, when 1 meter of polyethylene shielding was placed in front of the NTD, the damage was decreased by a factor of two.<sup>6</sup> Other types of shielding, such as paraffin wax, concrete, water, and boron have been found to be somewhat effective.<sup>7</sup> Future research may reveal other means to extend the period of time in which the CCD can be utilized.
