# Damage Mechanisms in Multilayer Dielectric Gratings at Different Pulse Durations

B. N. Hoffman,<sup>1</sup> A. A. Kozlov,<sup>1</sup> N. Liu,<sup>2</sup> H. Huang,<sup>1</sup> J. B. Oliver,<sup>1</sup> A. L. Rigatti,<sup>1</sup> T. J. Kessler,<sup>1</sup> A. Shestopalov,<sup>1,2</sup> and S. G. Demos<sup>1</sup>

<sup>1</sup>Laboratory for Laser Energetics, University of Rochester

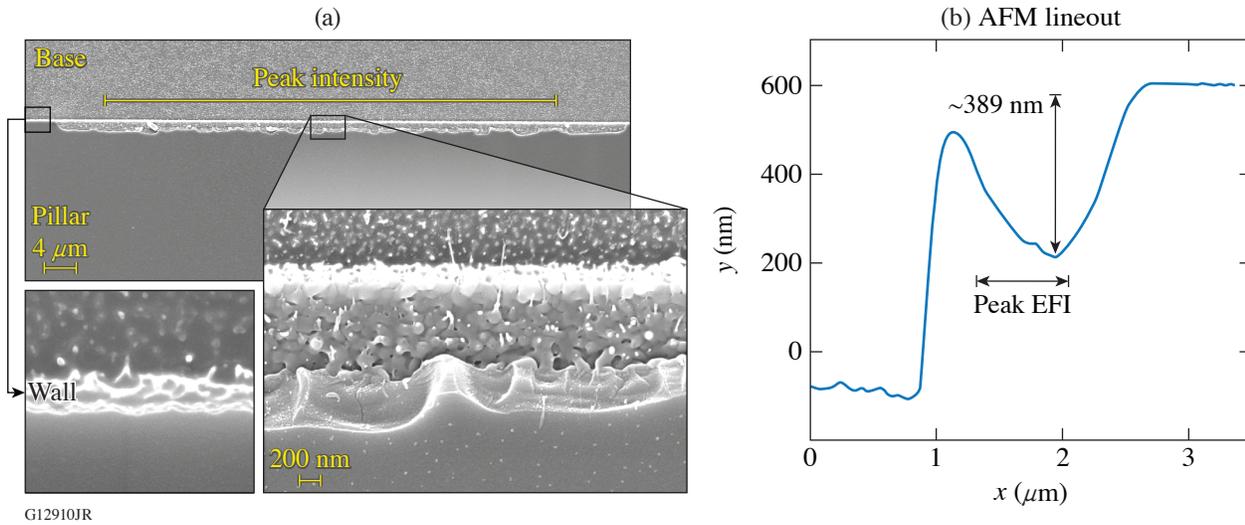
Figure 2

Previous work by Kozlov *et al.*<sup>5</sup> demonstrated that there are three types of laser-induced–damage mechanisms in multilayer dielectric coatings. Type-I damage is driven by the EFI enhancements within the most vulnerable material layer and involves removal of the overlying material over the area of peak laser intensity. Type-I damage occurs with pulse widths shorter than 2.5 ps. The damage mechanisms of the pillar wall of the grating-like structure for 0.6-ps laser pulses showed distinct signatures of the type-I damage mechanisms, such as a removal of coating sections within the area of the peak laser-beam intensity [see Fig. 2(a)] and a damage crater depth similar to the depth of the EFI enhancement [see Fig. 2(b)]. The morphology of the crater involves melted nanoscale projections from the explosive boiling process and the sharp crater edges, which are reminiscent of type-I craters observed with MLD high-reflector coatings [see Fig. 2(a), right inset image].

(a) Scanning electron microscope (SEM) images of the wall region in millimeter-pitch grating-like structures containing a damage site generated with a 0.6-ps pulse. The left inset shows in higher magnification the undamaged part of the wall region, and the right inset shows a section of the damage region. The laser beam impinges from the top at 61°. (b) A cross-sectional lineout of the damage region obtained with atomic force microscopy imaging reveals the depth and exact position of the damage site.

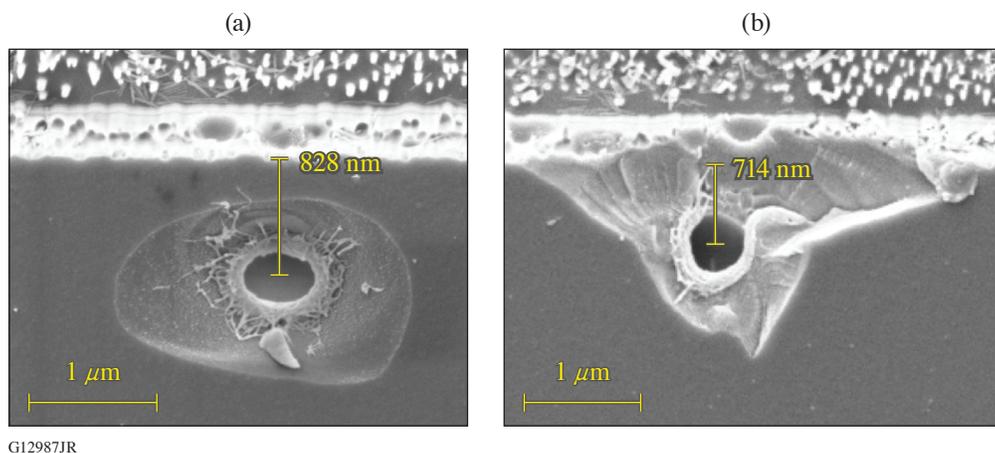
G12987JR

The type-II and type-III damage initiation processes in MLD coatings occur with laser pulses longer than 2.5 ps and are defect driven, resulting in the formation of micrometer-size craters. It was previously discussed that the temperature and pressure relaxation pathways following plasma formation at the defect location govern the morphology of the type-II damage.<sup>5</sup> The damage mechanisms observed on the grating-like pillar wall irradiated by 10-ps laser pulses (see characteristic examples in Fig. 3) are consistent with defect-driven damage near the EFI maximum enhancement, which is analogous to the type-II damage observed with MLD coatings.

Figure 3  
SEM images of damage sites generated under 10-ps pulses in the wall region in a millimeter-pitch grating.

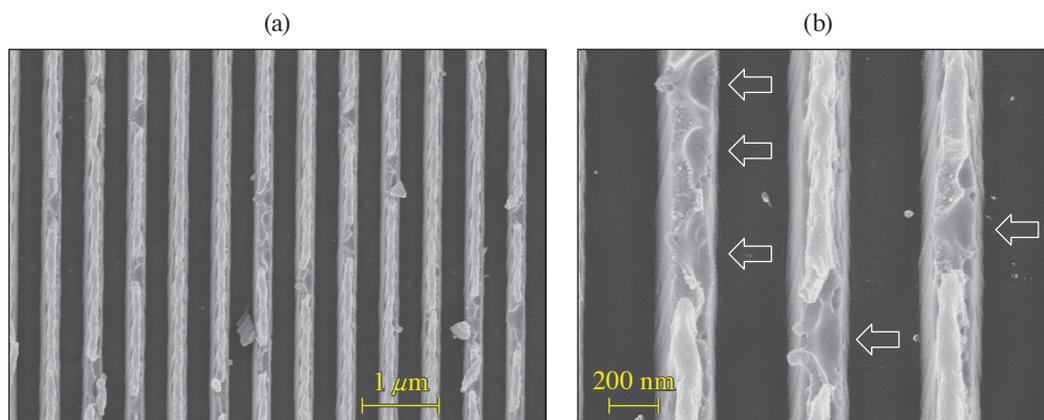
G12985JR

Although damage in MLD gratings includes pillar removal, thereby concealing the primary signatures of the damage mechanisms, the use of grating-like structures helped us to recognize fingerprint signatures on which to draw correlations. MLD grating damage sites generated with 0.6-ps pulses exhibit modification on the pillar wall, primarily on the right side where the EFI enhancement is known to be maximum [see Figs. 1(b) and 4] along with melted nanoparticles between damage pillars [see Fig. 4(b)]. These observations are consistent with the mechanisms and signatures observed with the grating-like structures seen in Fig. 2. Specifically, damage causes removal of sections of the pillar at the locations of maximum EFI while melted nanoparticles are observed between the pillars, which correspond to the nanoscale projections observed at the bottom of the type-I crater for the grating-like structures (separation of nanodroplets from the superheated material).

Figure 4  
SEM images of areas of an MLD grating where (a) laser-induced damage was initiated under a single 0.6-ps laser pulse and (b) the image of the central region at a higher magnification shows nanoparticle distribution. The laser excitation impinges on the samples at a 61° angle of incidence from the left side.

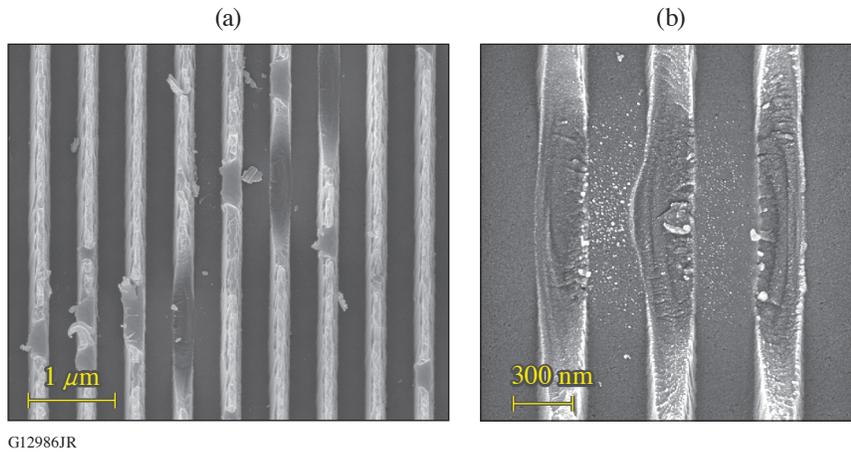
Figure 5

The primary morphology of laser damage in MLD gratings under 10-ps irradiation also involves removal of pillars, but there are characteristic differences from the pillar damage observed with 0.6-ps pulses. First, pillar removal often involves the entire pillar, not just the side. Second, the 10-ps damage consists of isolated sites that often span multiple pillars [see Fig. 5(a)]. Lastly, a larger number of melted nanoparticles [see Fig. 5(b)] as well as fragments [see Fig. 5(a)] are present within or near damage sites. This type of damage is suggestive of the type-II damage as also observed with the grating-like structures. However, the boundary conditions due to the small size of the grating pillars must be considered. Specifically, since the depth of the damage-initiating defect can vary, damage can initiate at different locations within the pillars. This gives rise to a variability on the damage morphology, including the height of the removed sections of the pillars as well as the number of pillars involved for each individual damage site. However, the distribution of generated nanoparticles within the trenches provides a fingerprint of the exact locations of the pillar involving the explosive boiling (damage).

SEM images of areas of an MLD grating where (a) laser-induced damage was initiated under a single 0.6-ps laser pulse and (b) the image of the central region at a higher magnification shows nanoparticle distribution. The laser irradiation impinges on the samples at a  $61^\circ$  angle of incidence from the left side.
