# An Intrinsic Laser-Damage Mechanism in Next-Generation OMEGA UV Multilayer Coatings

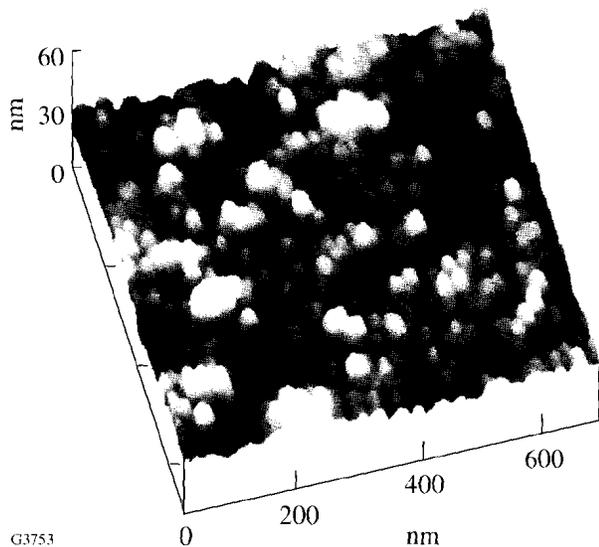
Figure 62.1  
Columnar structure of the  $\text{HfO}_2$  top surface ( $700 \times 700\text{-}\mu\text{m}$  scan) of a  $\text{HfO}_2/\text{SiO}_2$  multilayer HR stack.

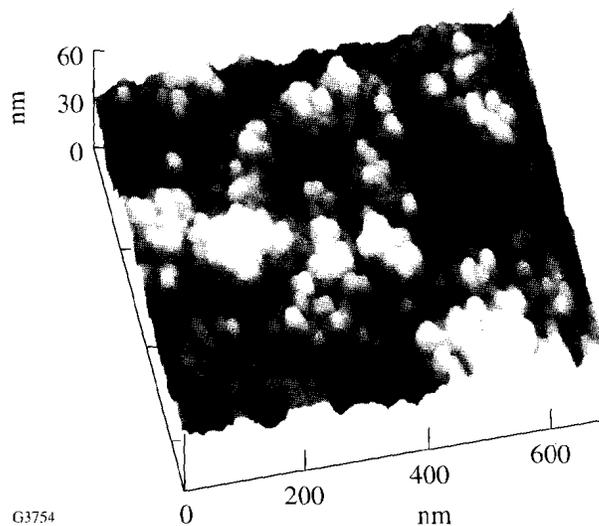
Figure 62.2  
Columnar structure of the  $\text{Sc}_2\text{O}_3$  top surface ( $700 \times 700\text{-}\mu\text{m}$  scan) of a  $\text{Sc}_2\text{O}_3/\text{SiO}_2$  multilayer HR stack with reduced  $E$ -field design.

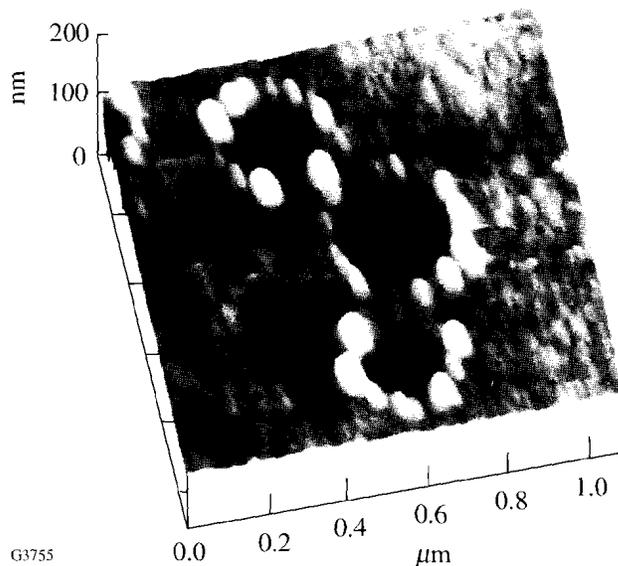
In both  $\text{HfO}_2/\text{SiO}_2$  and  $\text{Sc}_2\text{O}_3/\text{SiO}_2$  coatings, craters on the scale of 200 nm to 700 nm across and up to 130 nm deep are the main laser-damage features (Figs. 62.3 and 62.4). Their spatial correlation with the incident beam-fluence profile recorded in a sample equivalent plane by a CID camera is weak or nearly nonexistent. Under weakly damaging conditions,

Figure 62.3  
Conventional laser-damage craters formed by 351-nm radiation in the  $\text{HfO}_2/\text{SiO}_2$  film. The area shown corresponds to the periphery of a moderate-damage site.

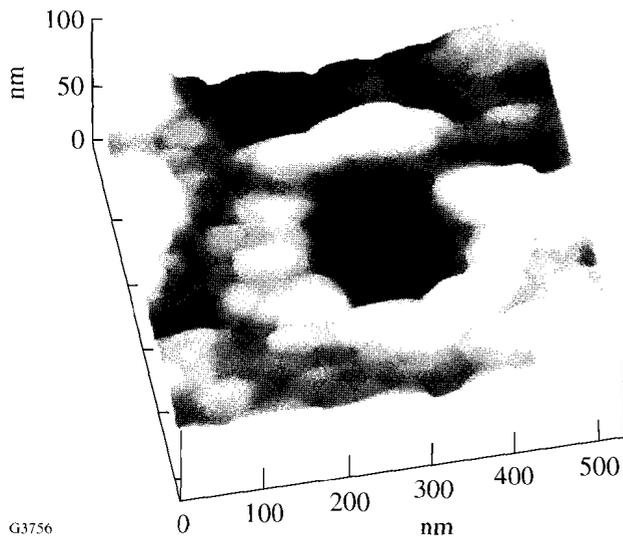
Figure 62.4  
Conventional laser-damage crater formed by 351-nm radiation in the  $\text{Sc}_2\text{O}_3/\text{SiO}_2$  film. The crater is 38 nm deep and, on average, 300 nm in diameter.

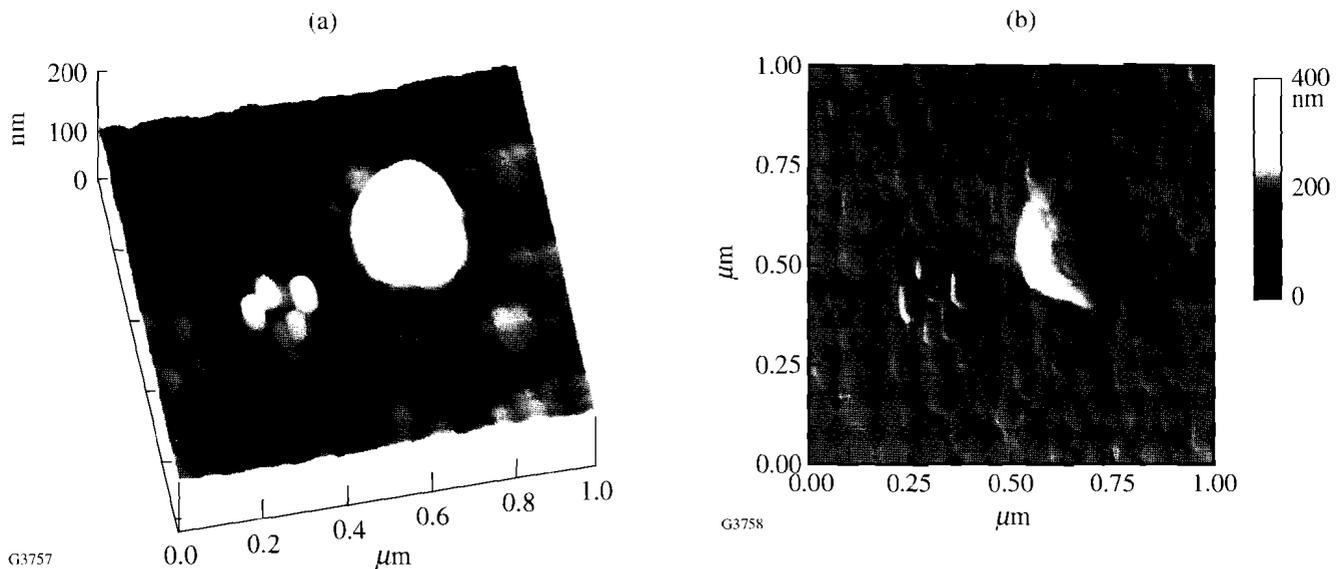
crater-to-crater average distances are  $2.4 \mu\text{m}$  for  $\text{HfO}_2/\text{SiO}_2$  and  $2.7 \mu\text{m}$  for  $\text{Sc}_2\text{O}_3/\text{SiO}_2$ . In agreement with our earlier findings on 1054-nm laser-irradiated monolayer films,<sup>6</sup> such craters develop independently of whether or not micron-scale growth nodules are present. Figure 62.5 demonstrates that growth nodules and inclusions can remain unaffected, even under 351-nm irradiation, while other defect-driving mecha-

nisms dominate crater formation in the nodules' immediate vicinity. Up to now, we have been unable to offer similar evidence for 1054-nm HR stacks. Within that constraint, the current evidence suggests that growth nodules *are not always* the dominating cause of damage. We have, in fact, no AFM evidence or visible-light microscopy record for any observable feature that could be used as a landmark for predicting the occurrence of these craters.

Figure 62.5  
(a) Crater formed in the vicinity of an unaffected nodular growth defect in the  $\text{HfO}_2/\text{SiO}_2$  film. The columnar structure of the nodule surface is masked by the saturating dome height ( $\sim 200$  nm) relative to the only 15-nm peak-to-valley excursions characteristic for the columnar structure. (b) High-pass filtered version of the image in Fig. 62.5(a), highlighting the columnar structure and nodular nature of the defect.

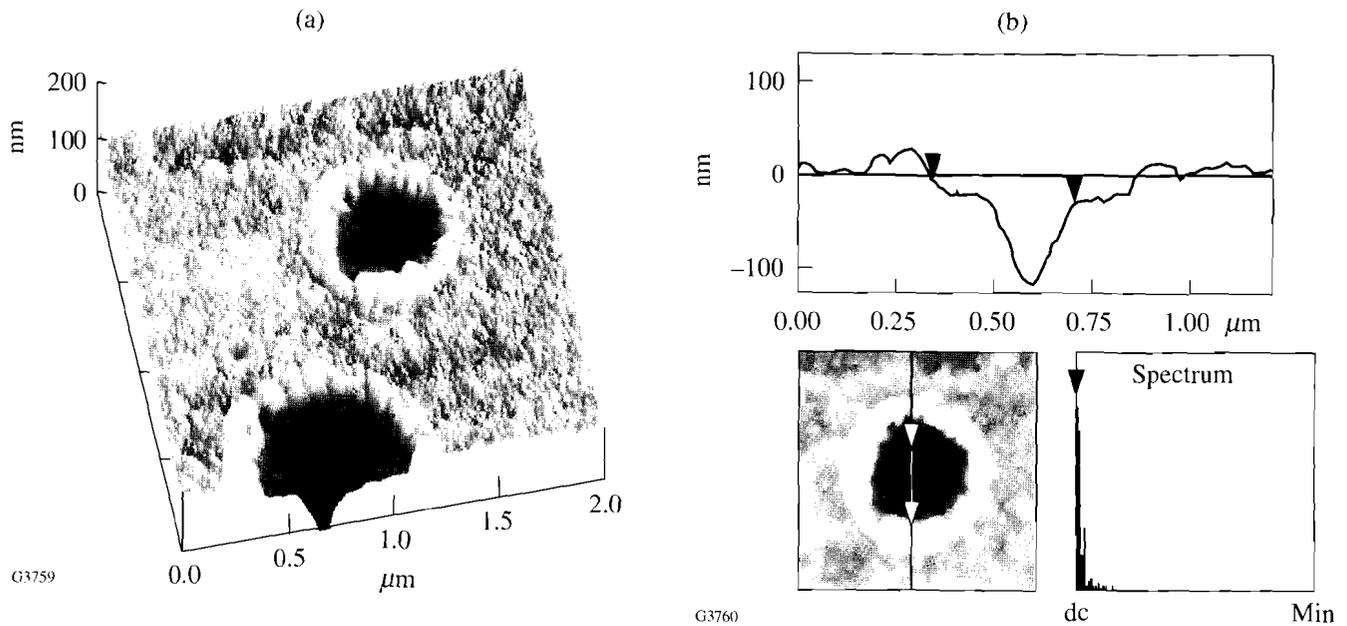
Figure 62.6

Modern AFM tools now permit greater insight into crater cross-sectional features than were observed 14 years ago. We have found many instances in which a conventional, conedged crater is superimposed on a second, deeper crater (see Fig. 62.6). These complex craters occur mainly in  $\text{Sc}_2\text{O}_3/\text{SiO}_2$  with an abundance level of 37%. Conventional craters show conical walls that are normally smooth and without any grain

(a) Complex crater(s) in the  $\text{Sc}_2\text{O}_3/\text{SiO}_2$  film show the preserved columnar structure within the outer, larger-diameter cone. This indicates that melting remains localized within the inner cone volume, i.e., the  $\text{SiO}_2$  layer. (b) Cross section through the complex crater in the  $\text{Sc}_2\text{O}_3/\text{SiO}_2$  film. The double-cone structure is clearly pronounced here, as well as the 32.8-nm step formed by the outer cone.

Without detailed simulation, it remains unclear whether the observed double-cone damage is driven by starting events in the first or the second layer. In each scenario, the large difference in melting temperature between  $\text{SiO}_2$  ( $T_m = 1753^\circ\text{C}$ ) and  $\text{Sc}_2\text{O}_3$  ( $T_m \sim 2400^\circ\text{C}$ ) is essential in explaining the observed morphology. As the  $\text{SiO}_2$  crater walls yield no columnar-structure indicators, we can assume that melting has occurred in the  $\text{SiO}_2$  layer. Conversely, the columnar spatial frequencies typical of the unirradiated film are maintained around the

$\text{Sc}_2\text{O}_3$  crater walls and ridges, which rules out large-scale melting in that layer [Fig. 62.6(a)]. Temperatures insufficient for melting in  $\text{Sc}_2\text{O}_3$  are adequate to produce thermal expansion and possible buckling of the 25- to 32-nm top layer that, with or without further pressure from the underlying, melted  $\text{SiO}_2$  layer, severed along grain boundaries and “popped out.” In the event that the initiating absorber was lodged in the second ( $\text{SiO}_2$ ) layer, the melting of that layer preceded the thermal distortion of the top layer. If the absorber was instead in the top layer, heat from that layer must first propagate across the layer boundary at a flow rate that supports melting of  $\text{SiO}_2$  columns before the top layer pops out. On the basis of post-mortem evidence alone, the dominant or most likely mechanism cannot be determined with any certainty.

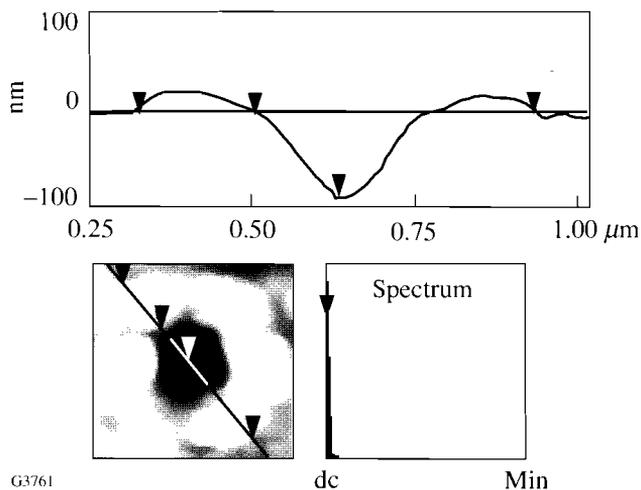
structure with ridges elevated above the film surface average (Fig. 62.7). In complex craters, the inner, deeper cone also shows smooth, glassy walls, while the outer cone and the horizontal interface clearly preserve columnar structure. Although the horizontal step between the outer and inner cones occurs reproducibly at  $32.8 \pm 0.3$  nm from the nominal top surface average (36 craters were sampled for this value by AFM determination) and intuitively corresponds to the  $\text{Sc}_2\text{O}_3/\text{SiO}_2$  interface, the top-layer ( $\text{Sc}_2\text{O}_3$ ) physical thickness determined during evaporation by quartz-microbalance and optical-monitoring methods is supposed to be  $25.4 \pm 3$  nm. We ascribe this discrepancy to the uncertainty in material-density and refractive-index values for evaporated thin films when extracting physical thickness data from mass deposition and interference numbers.

Figure 62.7  
Cross section through the 46-nm-deep conventional crater in the  $\text{Sc}_2\text{O}_3/\text{SiO}_2$  film. Smooth, glassy walls offer evidence of melting as part of the damage process.

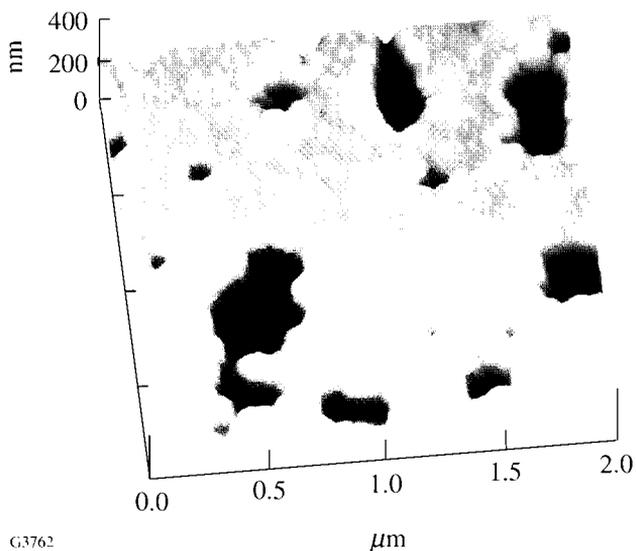
Superimposed, double-crater damage is absent in the  $\text{HfO}_2/\text{SiO}_2$  system. Conventional craters become more numerous and, if sufficiently adjacent to one another, merge as the level of damage increases in this system (Fig. 62.8). In spite of earlier reports to the contrary<sup>8</sup> that rank quarter-wave layers of  $\text{SiO}_2$  at nearly a factor of 2 higher in 351-nm thresholds than equivalent  $\text{HfO}_2$  layers of the same thickness, all merging craters in our samples originate in the  $\text{SiO}_2$  layer after exposure to fluences *above threshold*. This issue will be discussed in detail in the next section.

Figure 62.8  
Merging craters in the central portion of a moderate-damage event in the  $\text{HfO}_2/\text{SiO}_2$  film.

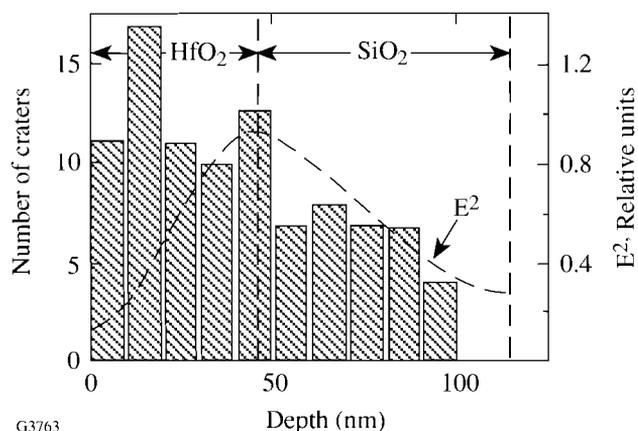
a.  $\text{HfO}_2/\text{SiO}_2$ . The weak-damage results summarized in Fig. 62.9 show that craters originate in the first or second layer only, with the majority originating in the 46-nm-thick  $\text{HfO}_2$  layer. The distribution peaks at a depth near 20 nm and shifts to greater depths with increasing fluence. At the periphery of moderate damage (Fig. 62.10), two peaks appear in the distribution at 30 nm and 80 nm, respectively; in the center of moderate damage, craters appear only infrequently in the  $\text{HfO}_2$  layer, while the distribution peak centers around 75 nm (Fig. 62.11). In the latter case, a few damage events originate near the interface between the second and third layers, but none were observed protruding into the next  $\text{HfO}_2$  layer. Concurrent with this shift of craters to greater depths is an increase in both their density (more than an order of magnitude higher for moderate damage than for near-threshold damage) and their tendency to merge.

Figure 62.9  
Crater-depth distribution (histogram) for weak-damage conditions ( $\sim 5\%$  above threshold fluence) in the  $\text{HfO}_2/\text{SiO}_2$  system. The majority of craters originate within the top  $\text{HfO}_2$  layer.

Figures 62.9 and 62.10 show also the E<sup>2</sup>-optical-intensity dependence inside the first two stack layers, which peak exactly at the interface. Other local maxima are located at the interface between the third and fourth layers, etc., with each

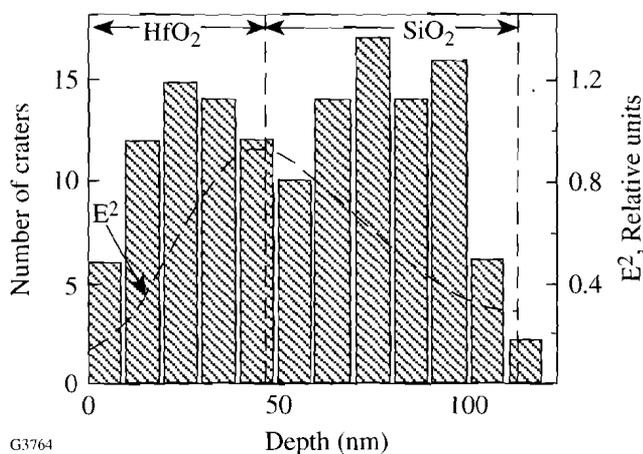
Figure 62.10 Crater-depth distribution (histogram) for moderate-damage (periphery) conditions in the HfO<sub>2</sub>/SiO<sub>2</sub> system. The second peak at 80-nm depth may be attributed to the combined effects of excess energy (relative to weak-damage conditions) and heat propagation from the higher-melting-point HfO<sub>2</sub> layer to the lower-melting-point SiO<sub>2</sub> layer.

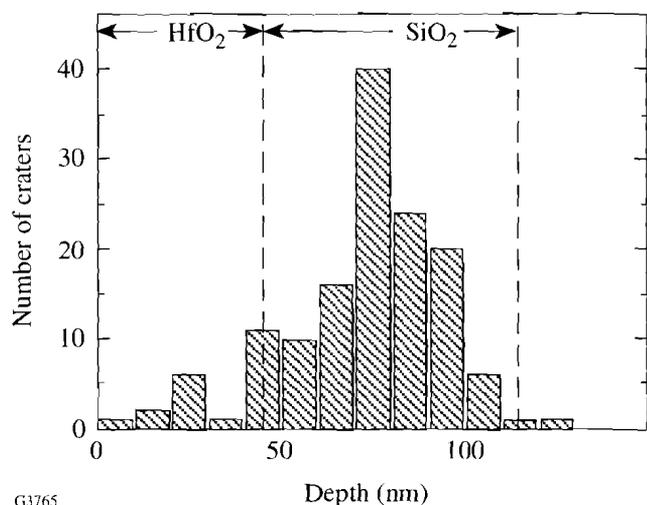
Figure 62.11 Crater-depth distribution at the central portion of a moderate-damage area (~20% above threshold fluence) in the HfO<sub>2</sub>/SiO<sub>2</sub> system. The distribution is now fully shifted into the SiO<sub>2</sub> layer, indicative of the dominance of heat-propagation effects under the 20%-above-threshold fluence conditions.

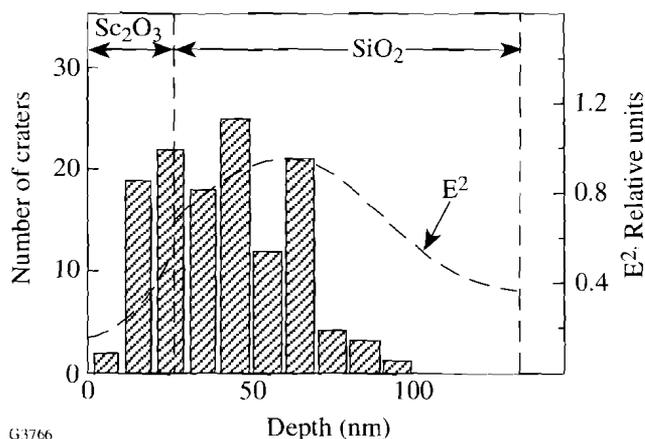
b. Sc<sub>2</sub>O<sub>3</sub>/SiO<sub>2</sub>. In the Sc<sub>2</sub>O<sub>3</sub>/SiO<sub>2</sub> system the top Sc<sub>2</sub>O<sub>3</sub> layer is only 25.4 nm thick, and the peak of the E<sup>2</sup>-intensity distribution has been designed to not coincide with the layer interface. For this system, the intensity peaks at a depth of 65 nm. Both factors bias the crater-depth distribution toward the SiO<sub>2</sub> layer, as seen in Figs. 62.12 and 62.13 for the cases of weak damage and peripheral moderate damage. As was true for HfO<sub>2</sub>/SiO<sub>2</sub>, no craters originate from beneath the second layer. However, the shift of the distribution peak in going from weak to moderate damage (~40 nm in HfO<sub>2</sub>/SiO<sub>2</sub>) is more modest in this system. The 10-nm difference between distribution peaks in Figs. 62.12 and 62.13 is too small to be considered significant in light of the 10-nm bin width.

The trailing edges of the distributions shown in Figs. 62.12 and 62.13 drop faster with depth than the incident intensity,

Figure 62.12 Crater-depth distribution (histogram) for weak damage in the Sc<sub>2</sub>O<sub>3</sub>/SiO<sub>2</sub> system. Owing to the relatively thin (25.4-nm) Sc<sub>2</sub>O<sub>3</sub> layer, the E-field, i.e., intensity, peaks inside the SiO<sub>2</sub> layer.

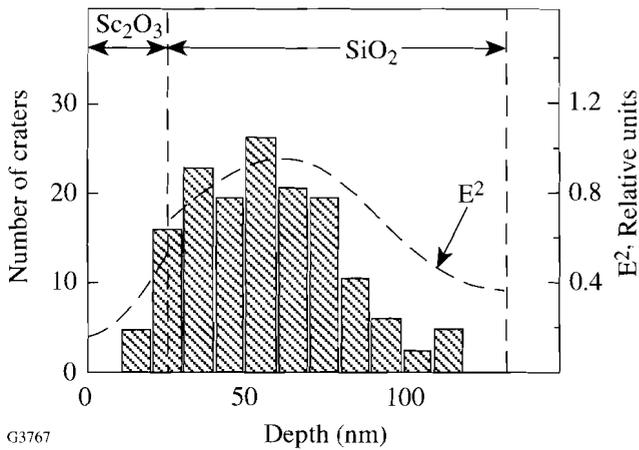
Figure 62.13

Crater-depth distribution (histogram) for moderate-damage (periphery) conditions in the  $\text{Sc}_2\text{O}_3/\text{SiO}_2$  system. The distribution is almost fully bracketed within the  $\text{SiO}_2$  layer.
