## Status of Optics on the OMEGA Laser after Eighteen Months of Operation

The OMEGA laser has sustained approximately 1000 target shots over its first 18 months of operation without significant damage to the optics. Both rod and disk amplifiers are used in the OMEGA laser chain; after each amplification stage at  $1\omega$  the beams are spatially filtered to remove high-spatial-frequency noise in the beam and to ensure correct image relaying. Optical damage thresholds dictated the minimum beam diameter in each stage and fixed the magnification between stages. The final 28-cm beam propagates through thin-film polarizers before reaching the frequency-conversion cells.<sup>1-3</sup> Frequency conversion to the third harmonic (351 nm) is carried out using the polarization-mismatch method developed at LLE.<sup>4,5</sup> A set of mirrors transports the  $3\omega$  beams through a final focus lens, and the last optic in the beam path serves as the vacuum barrier for the target chamber.

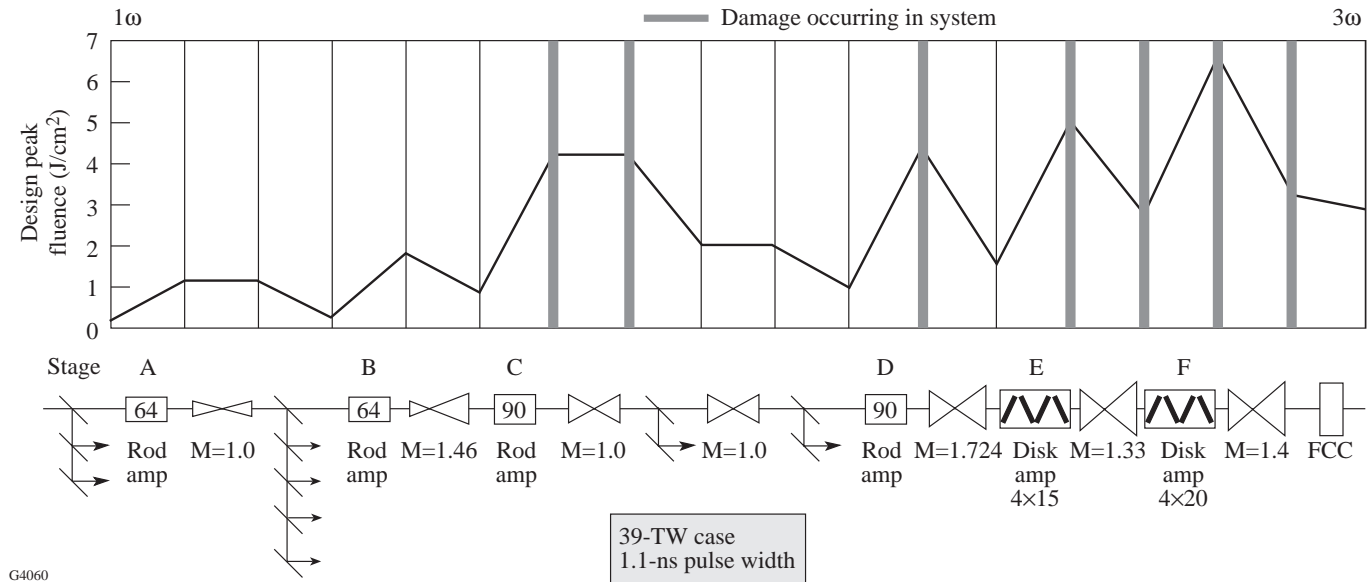
As the laser continues to operate, it is not surprising to observe operational damage in optics located at high-fluence positions of the laser. Figure 70.1 shows a staging diagram that plots the peak design fluence—average fluence times a 1.8 intensity modulation factor—at each stage of a single beamline on OMEGA.<sup>7</sup> The bold lines indicate areas where laser damage is occurring at present. Specific damage morphologies are presented on p. 52.

Figure 70.1  
Peak design fluence plotted at each stage of the OMEGA laser. Operational laser damage is occurring at the high fluence positions.

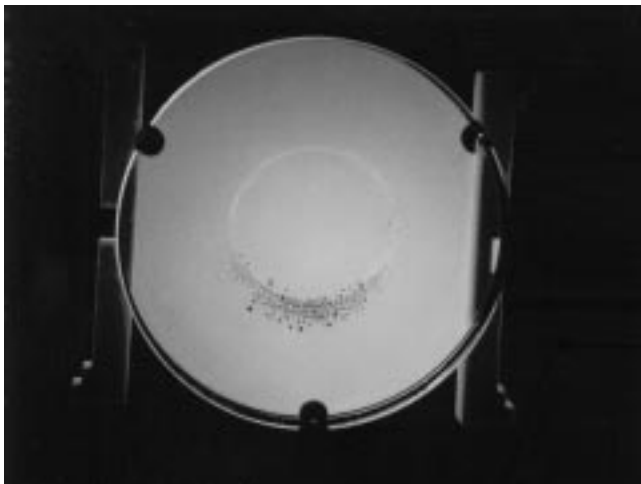
While accidental laser damage occurs infrequently, it can result in significant optics damage. During the activation stage of OMEGA, six optics were damaged in a single shot when light back-propagated after striking the edge of an improperly positioned spatial filter pinhole assembly. The ring of damage is located at the edge of the beam diameter and was caused by the radial edge gain from the rod amplifiers. This beam imprint was observed on several mirrors and the liquid crystal component shown in Fig. 70.2.

G3887  
Figure 70.2  
A malfunctioning spatial filter pinhole assembly caused the accidental damage to this liquid crystal polarizer component (135-mm diameter).

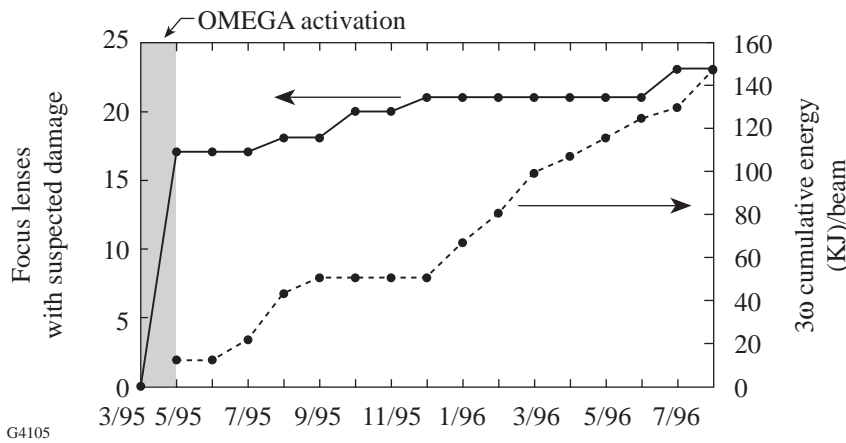
the blastshield optic located about 75 mm in front of the lens or to opposing beam port optics. Figure 70.3 shows a timeline of the discovery of damaged focus lenses. At the end of OMEGA activation, a large number of focus lenses were suspected to have damage, with only a slight increase since the initial observation. We believe this damage does not result from the normal operation of the laser because the plot of energy does not correlate with the number of damaged lenses

reported. However, continued laser operation does contribute to the growth of the existing accidentally damaged site. During activation, a train of short pulses propagated down the system and were frequency converted to  $2\omega$ , instead of  $3\omega$ , which may have caused the damage. Since the sol-gel coating was designed for  $3\omega$ , a 2%–3% surface reflection occurs at  $2\omega$ . Analysis of multiple beam reflections inside the lens results in the formation of a  $2\omega$  caustic at the lens' center position 2 mm from the exit surface.<sup>9</sup>

Figure 70.3  
Observation timeline of OMEGA final focus lenses. The left axis plots the number of damaged focus lenses observed over the lifetime of the laser. The right axis plots the 3 $\omega$  cumulative energy per beam over that same time frame.

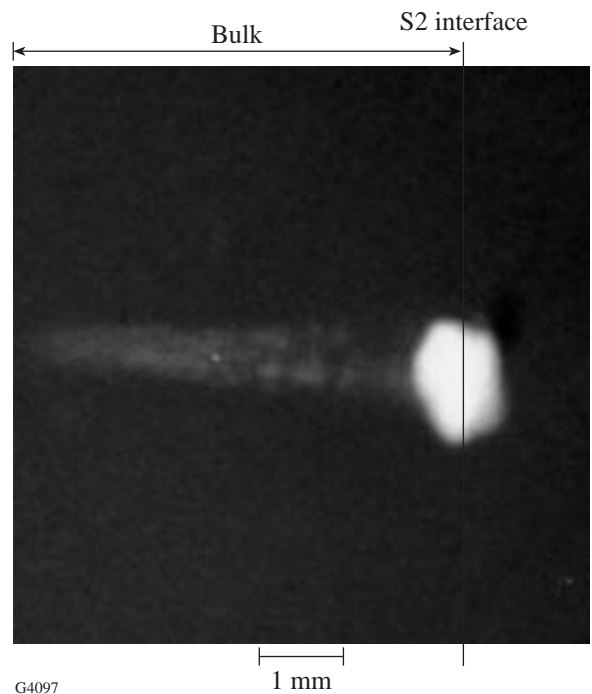
**Self-focusing damage** is seen infrequently in OMEGA lenses. Currently, nine fused silica lenses have evidence of “angel-hair” tracking, which occurs in the bulk material. These tracks appear as a linear sequence of microscopic damage in the bulk of the optic aligned with the propagation axis. Table 70.I provides a list of the damaged components and the peak fluences they are subject to.

Figure 70.4 shows a photograph of self-focusing damage observed on an OMEGA lens. The large white spot is in the exit surface of the lens, and the typical diameter of this damage area is 1 mm. This large area contains a number of smaller, individual damage sites formed when the self-focusing tracks intercepted the output surface of the lens. These sites do not seem to grow on successive laser shots.

Figure 70.4  
“Angel-hair” tracking damage observed in the bulk glass of an OMEGA stage-F input lens. The large bright area is the exit surface of the lens.

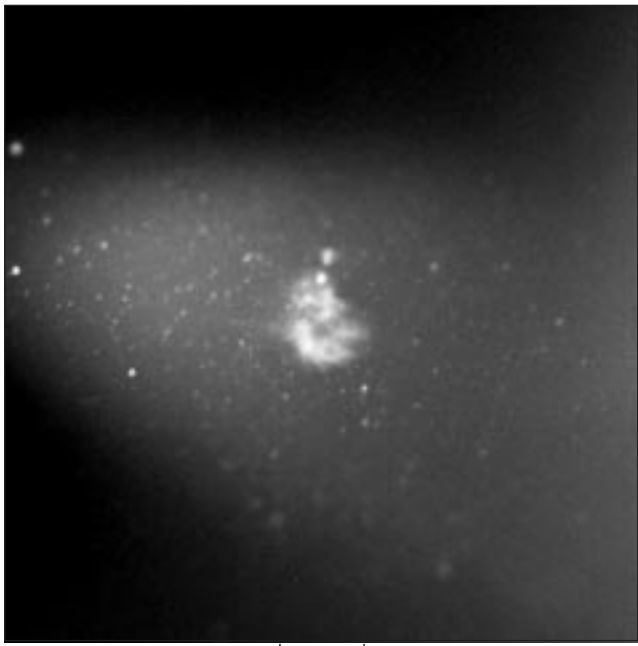
Figure 70.5

**Plasma scalds** are frequently seen on OMEGA’s 3 $\omega$  transport mirrors. As seen in Fig. 70.5, scalds appear as a

Plasma scalds are frequently seen on OMEGA's  $3\omega$  transport mirrors.

discoloration on the coated surface of the mirror. Scalds are initiated where particulates are on the mirror surface during a laser shot and are caused by an increase of temperature on the surface during plasma formation.<sup>10</sup> OMEGA transport mirrors are *not* contained in enclosed structures but are mounted in open, upward/downward-facing structures. This open architecture, which allows personnel access to target chamber equipment, results in an increased level of contamination on target bay optics as opposed to laser bay optics, which are vertically mounted with protecting covers on the structures. These plasma-scald defects do not grow in size on subsequent

laser shots, but the number of scalds per surface may increase. At this time, no reflectance data is available to determine how plasma scalds affect performance of the mirror coating.

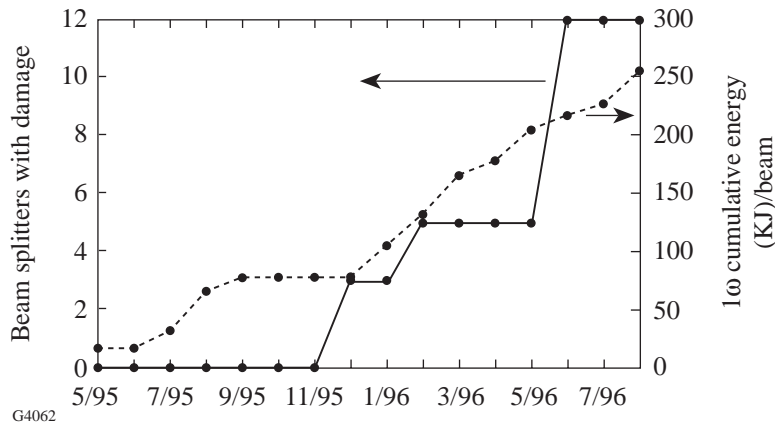
Figure 70.6

All tantala/silica **beam splitters** located in OMEGA's C-split region (which is the region with the highest fluence of any multilayer coating) have significant damage after 18 months of laser operation. From Fig. 70.6, it is apparent that this damage was not accidental but operational laser damage. As the beam splitters continued to see an increase in  $1\omega$  cumulative energy, the observed number of damaged beam splitters increased. Microscopic evaluation of a beam splitter revealed coating-damage sites that were initially 50 to 100  $\mu\text{m}$  in size and 7  $\mu\text{m}$  deep. This depth indicates that the tantala/silica coating is damaged at the substrate interface. The size of these damage sites continues to grow on successive laser shots. Figure 70.7 shows a photograph of a beam splitter with the damage sites illuminated within the beam diameter.

Observation timeline of OMEGA's stage-C beam splitters. The left axis plots the number of damaged beam splitters observed over the lifetime of the laser. The right axis plots the  $1\omega$  cumulative energy per beam over that same time frame.

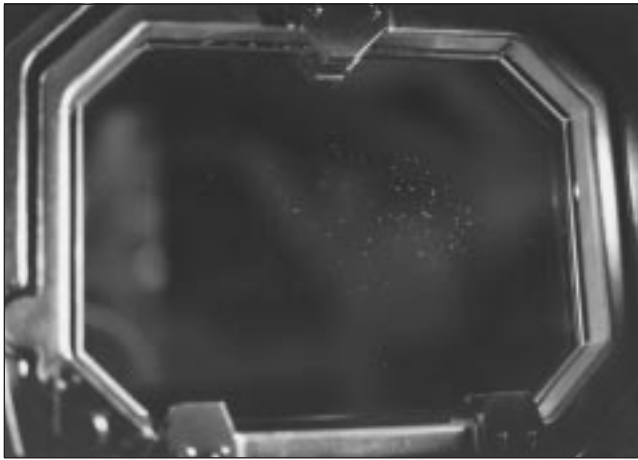
Figure 70.7  
Coating damage observed on a 5.5-in. × 7.5-in. OMEGA stage-C, tantalum/silica beam splitter. The highest fluence seen by a multilayer coating is in the C-split area.

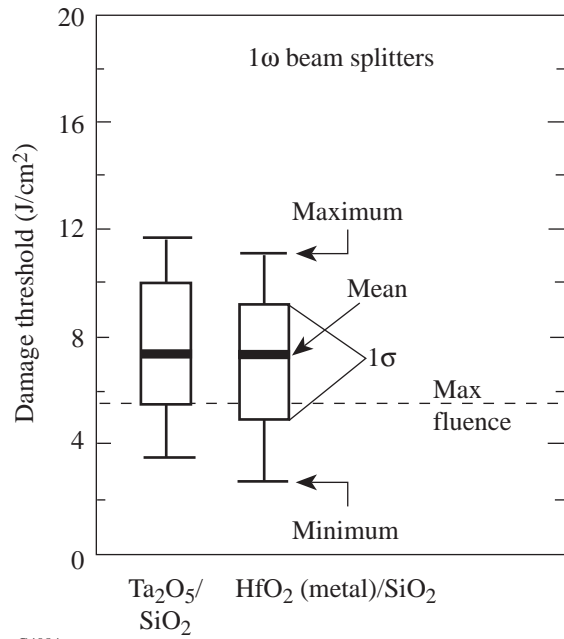
During the OMEGA Upgrade, two types of beam splitters were produced using either the tantala/silica design or the hafnia(metal)/silica design. Hafnia(metal)/silica-coated beam splitters located in the same area as the tantala/silica beam splitters show no signs of coating damage, even though they have the same test damage threshold.<sup>11</sup> These test damage thresholds (reported in Fig. 70.8) were taken on a limited number of sites, and, as a result of this limited statistical process,

defect sites may have been missed. The results on OMEGA are equivalent to full-aperture testing, and this type of testing has revealed significant differences in damage thresholds between the two materials. The highest fluence seen by a multilayer coating is in the C-split area (which is  $4.1 \text{ J/cm}^2$ ). Beam splitters in other areas see a lower fluence (typically  $\sim 1 \text{ J/cm}^2$ ), and neither design has demonstrated any sign of significant damage in these low fluence areas.

Figure 70.8  
Damage thresholds for tantalum/silica and hafnia(metal)/silica beam-splitter coatings measured at 1054 nm with a 1-ns pulse at *p*-polarization.

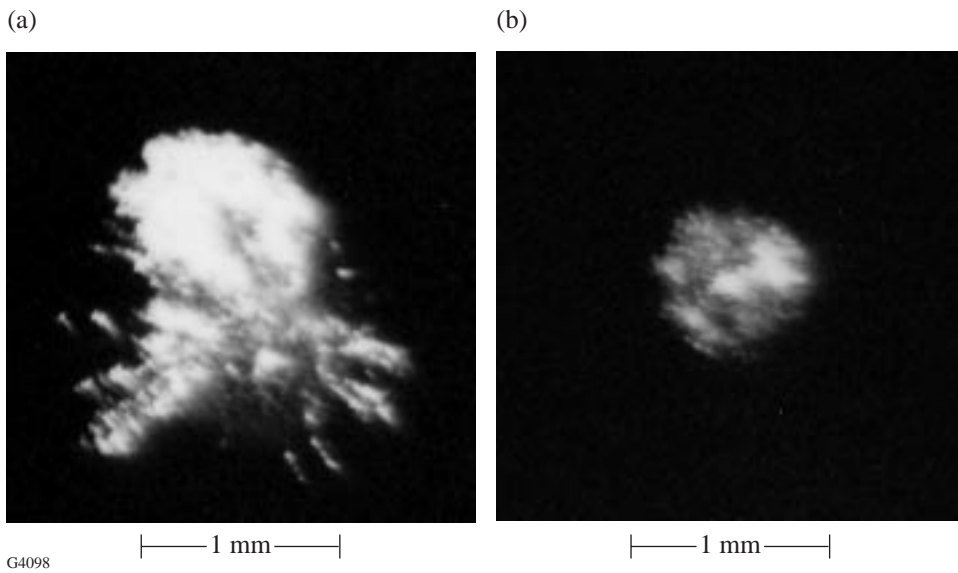
Each lens has one to four damage sites, ranging in size from 50 to  $800 \mu\text{m}$ , occurring at varying depths within the bulk glass. Photographs of damage sites from an OMEGA lens are shown in Fig. 70.9. Microscopic evaluation revealed damage sites

with radial fractures forming a circular pattern perpendicular to the beam. This type of fracture pattern is characteristic of platinum-inclusion damage.<sup>12</sup> Previous data reported by LLNL showed that platinum inclusions in phosphate glass cause fractures when irradiated by laser pulses above a threshold value of 2.5 to  $3.0 \text{ J/cm}^2$  with a 1-ns pulse.<sup>13</sup> These fractured sites do grow upon repeated irradiation, but this growth rate is slow with respect to a bimonthly inspection cycle. During inspection cycles, sizes are visually estimated by observation with a white-light source. Quantitative microscopic evaluation is difficult on *in-situ* optics inspection, so an accurate estimate of damage growth rate is not available. Currently, we have not observed any damage propagation from these lenses to other optics in the beam path.

Figure 70.9  
Damage patterns observed on an OMEGA stage-F, BK-7, output spatial filter lens. Fracture patterns indicate platinum-inclusion damage.

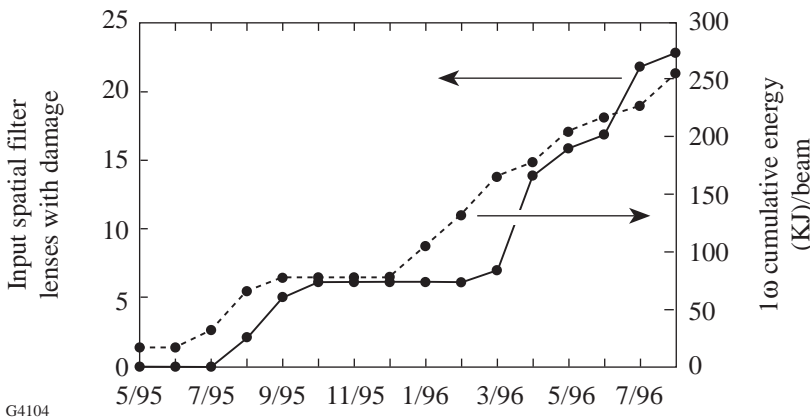
Large-scale fractured damage sites have been observed in OMEGA's stage-C, -D, -E, and -F input **fused-silica spatial filter lenses**. These areas of the system see some of the highest  $1\omega$  fluences and exceed the  $2.5 \text{ J/cm}^2$  criterion for the use of fused silica as opposed to BK7 glass (see Fig. 70.1 for the peak fluence in the OMEGA laser chain). The highest peak design  $1\omega$  fluence is at the F-input lenses with a fluence of  $6.6 \text{ J/cm}^2$ . The lowest  $1\omega$  fluence seen by these lenses is the C input, which has a fluence of  $4.1 \text{ J/cm}^2$ . Figure 70.10 shows a good correlation between the number of damaged lenses and the  $1\omega$  cumulative energy per beam plotted over the same time frame. As the  $1\omega$  cumulative energy per beam increases, the number of lenses with fractured damage sites also increases, indicating a form of operational damage.

Figure 70.10  
Observation timeline of OMEGA fused-silica, input spatial filter lenses. The left axis plots the number of damaged spatial filter lenses observed over the lifetime of the laser. The right axis plots the  $1\omega$  cumulative energy per beam over that same time frame.

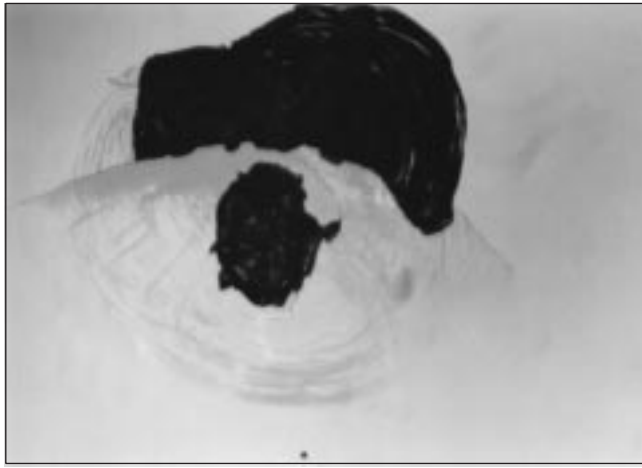
Figure 70.11

The damage occurs on the exit vacuum side of the lens at random locations, and the sites grow in size on subsequent laser shots. The damage does not correlate to hot spots in the beam and is believed to be initiated at surface particulate sites. Some possible contamination sources are particulate blowoff from the pinhole and debris from fabrication of the spatial filter vacuum tubes. A fraction of the beam strikes the edge of the pinhole, causing material to vaporize and redeposit on the vacuum side of the input spatial filter lens. Investigation into the cause of this damage is ongoing. The fracture pattern from one of these damage sites is seen in Fig. 70.11.

Fractured damage site observed on an OMEGA stage-C input, spatial filter lens.

Actual defects on OMEGA spatial filter lenses are shallow and elliptical, and these defects can be simulated with a half-penny-shaped defect ( $Y=1$ ) that has a surface diameter twice the defect depth. For an OMEGA stage-F input lens, 25 mm thick and 283 mm in diameter, a critical flaw depth of 8 mm is calculated for a half-penny defect on the vacuum side of a lens subjected to a tensile stress of 615 psi. A defect of this size will be easily detected before catastrophic failure occurs.

maximum bending stress for an OMEGA stage-F input lens is 615 psi and occurs at the center of the lens. If the model is correct, these lenses under full vacuum should not implode into several fragments when defects reach their critical flaw size but should crack into two pieces and lock together as long as the mount restrains the radial motion of the fragments. Although damage on the vacuum side of OMEGA spatial filter lenses has been observed, there has been no incident where an OMEGA spatial filter lens has cracked into several pieces. For safety concerns, OMEGA optics will be removed when defects reach one-half their critical flaw size (i.e., when the depth is 4 mm). For convenience we measure the surface trace *in situ* and replace any lenses with a surface trace of 8 mm (which would imply a depth of 4 mm if the flaw is penny shaped). We have replaced two lenses that had surface traces of 8 mm. Later depth measurements showed only a depth of 2 mm, well within the criteria for failure.

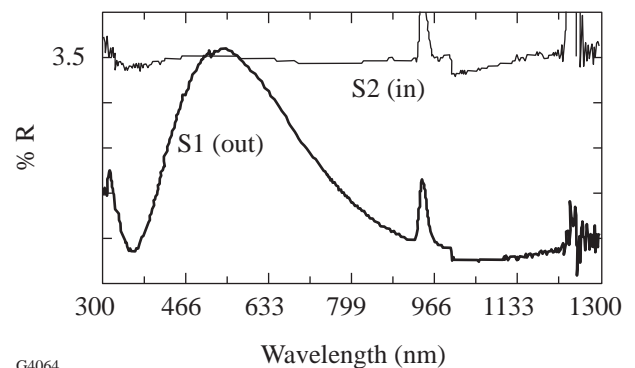
Figure 70.12

OMEGA’s sol-gel coatings show a significant change in reflectivity when exposed to a vacuum. A guided wave spectrometer is used to measure the reflectivity of optics mounted on OMEGA. While the instrument is not photometrically accurate, the shape of the spectral curve does provide information on the performance of the coating. The spectral data in Fig. 70.12 was taken on a  $1\omega$  (1053-nm) sol-gel-coated spatial filter lens. While the S1, non-vacuum-side, reflectivity curve is as expected for a  $1\omega$  antireflection coating, the S2, vacuum-side data indicates that the porous sol-gel coating has adsorbed some organic material, which has affected its coating performance. Evaluation of the contaminated sol-gel coating by gas chromatography mass spectrometry detected the presence of

Reflectance data measured on a sol-gel-coated spatial filter lens. The S2 (in) surface is the vacuum interface. The S1 (out) surface is *not* exposed to a vacuum.

vacuum pump oil. This coating problem is seen on all OMEGA sol-gel-coated spatial filter lenses that are pumped by a mechanically pumped system. Hard-oxide dielectric coatings pumped under similar vacuum conditions and sol-gel coatings pumped by an ion sublimation pump show no change in reflectivity after exposure to a vacuum. Since OMEGA's optical layout was designed with the assumption of a 4% light loss per surface, damage is not expected from ghost reflections and no system damage has occurred as a result of this coating problem.<sup>16</sup> Two solutions to this sol-gel-coating problem are being investigated: (1) replace the sol-gel coatings with hard-oxide dielectric coatings and (2) improve the spatial filter pumping system. Sol-gel coatings were used on all fused silica spatial filter lenses since these lenses have the highest  $1\omega$  fluence on the system and sol-gel coatings have, in the past, shown considerably higher damage threshold than hard-oxide coatings. Recent improvements in the hard-oxide coating process have resulted in increased damage thresholds, which now make them viable replacements to the sol-gel type.
