Damage to Fused-Silica, Spatial-Filter Lenses on the OMEGA Laser System

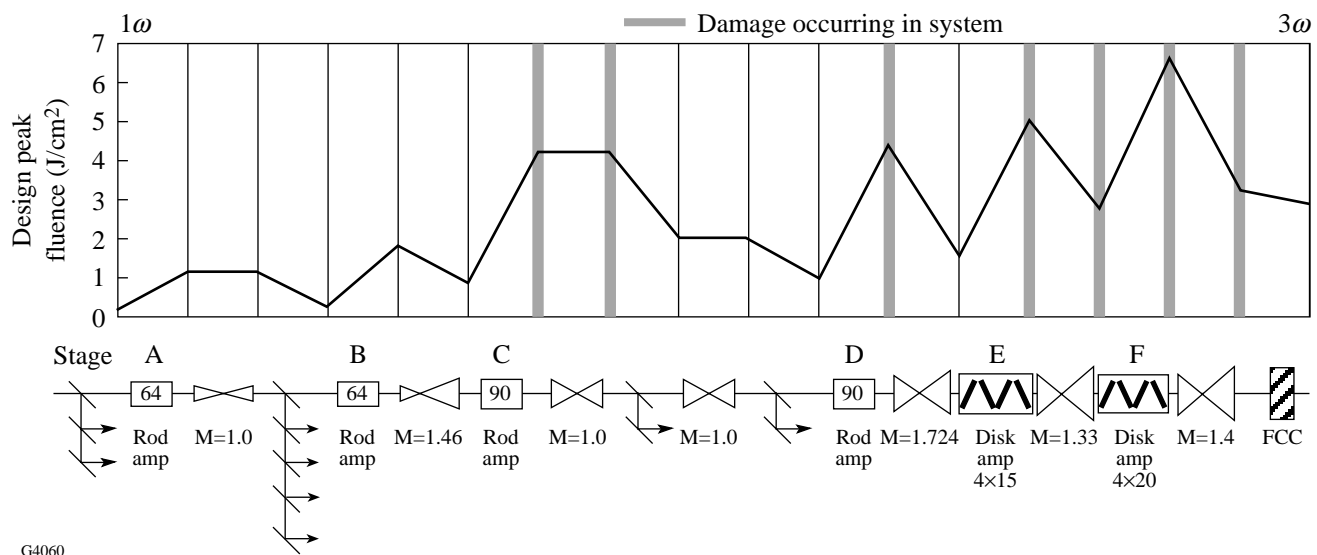
Figure 78.59
Peak design fluence plotted at each stage of the OMEGA laser. Operational laser damage is occurring at the high-fluence positions.

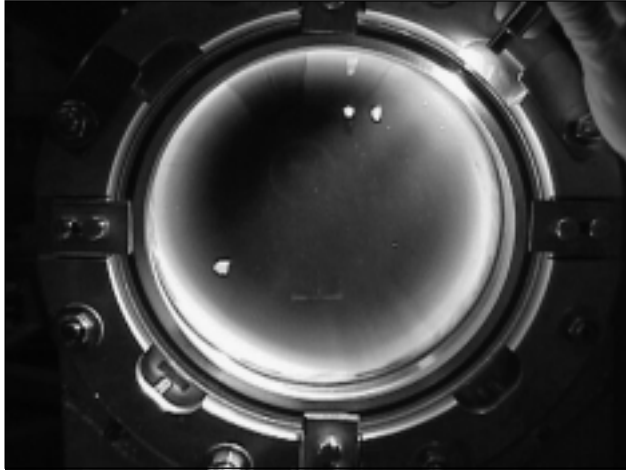
G4745

Figure 78.60
An OMEGA stage-E-input, spatial-filter lens with multiple fracture sites. The largest site is approximately 10 mm.

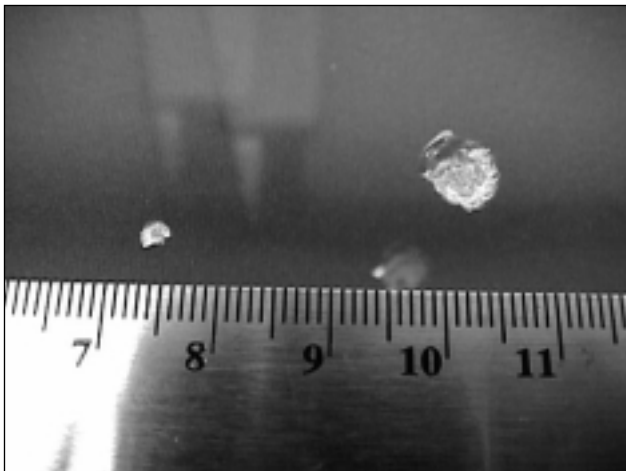
G4746

defects ranging in size from less than 0.5-mm to 10-mm diameter, and multiple damage sites on a lens's vacuum surface are common. The damage depth tends to be less than one-third its surface diameter, and defects occur at apparently random radial locations. A clam-shell defect is depicted in a side view in Fig. 78.62 and in a head-on view in Fig. 78.63. The flaw's discoloration may signal that it is being filled by an absorbing material. On repeated irradiation, the clam-shell morphology is eventually obliterated and a crater develops, as in Fig. 78.61.

Figure 78.61
Fractures on the vacuum side of an OMEGA lens. Scale units in centimeter.

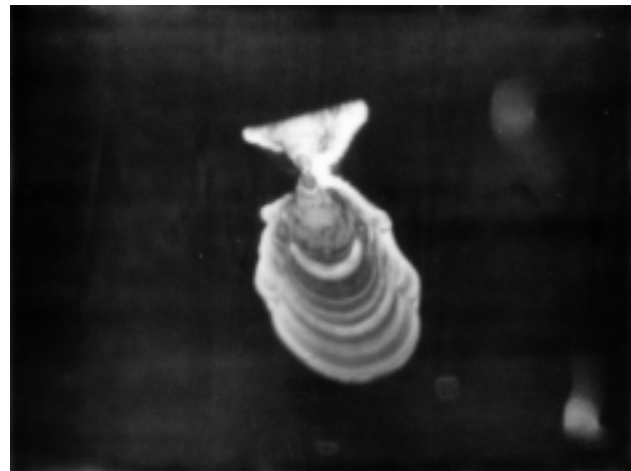
E4747

Figure 78.62
Clam-shell defect originating at the vacuum side (bulk view).

surface, oils from the machined surfaces of the spatial-filter tubes or oils from the mechanical pumping system seep into the crack over time. The combination of absorption by the trapped fluid and physical–chemical assistance in crack-front propagation during subsequent exposure is surmised to form the ring structure observed within the clam shell.

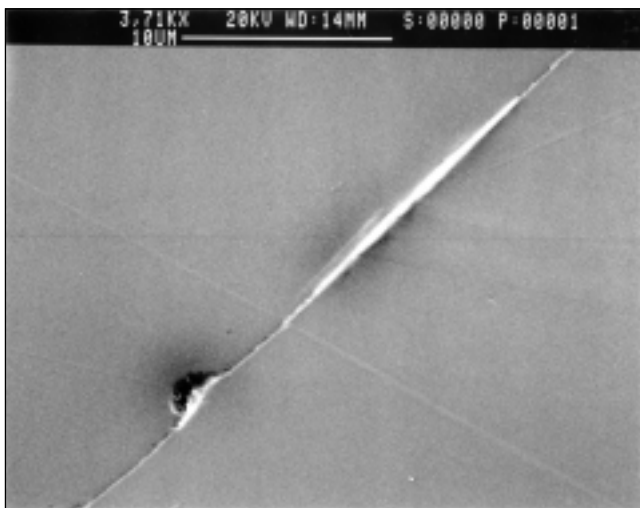
G4748

Figure 78.63
SEM vacuum surface view of a clam-shell defect on an OMEGA lens (top view).

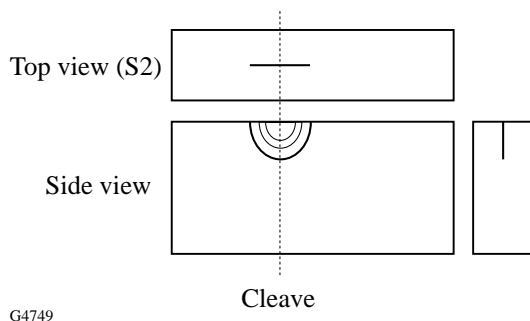
G4749

While this clam-shell morphology is one initiator of millimeter-sized fractures, it remains inconclusive whether it is the only one. To further evaluate clam-shell damage, a sample was cleaved, as depicted in Fig. 78.64, and the exposed clam-shell cross section was analyzed by scanning electron microscopy (SEM). SEM/EDAX (energy dispersive x-ray analysis) element identification revealed the presence of carbon within the fracture while reporting its absence outside the fractured area. It is surmised that once a crack appears on the vacuum-side

Figure 78.64
Illustration of cleave sample orientation.

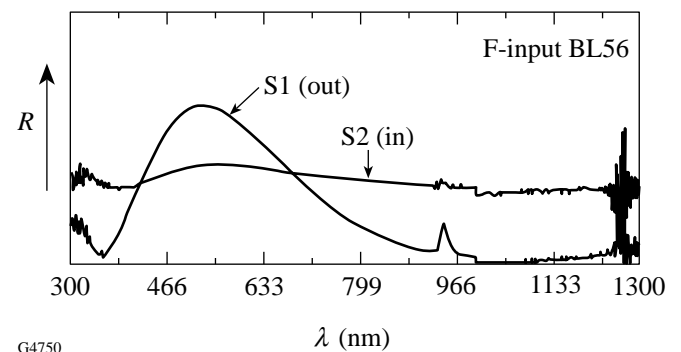
G4750

Figure 78.65
Reflectance data measured on a sol-gel-coated spatial-filter lens. The S2 (in) surface is the vacuum interface; the S1 (out) surface resides in air.

vacuum pressure levels within the spatial-filter tubes. Loss of reflectivity on a mechanically pumped tube is suffered in about six weeks or more. Hard-oxide dielectric coatings pumped under similar vacuum conditions show no change in reflectivity after exposure for similar periods.

A causal link between sol-gel contamination and lens damage is suspected but has yet to be fully proven. Experiments to investigate this link and solve this damage problem are ongoing, and some results are reported in the next section. In addition, several solutions to this sol-gel-coating degradation problem are being examined to recover the light loss imposed by each "bad" surface: (1) replace sol-gel coatings with hard-oxide dielectric coatings (damage threshold is a key factor); (2) improve the spatial-filter pumping system and clean the spatial-filter tubes; and (3) add a "getter" material to adsorb the contamination before it reaches the coating.

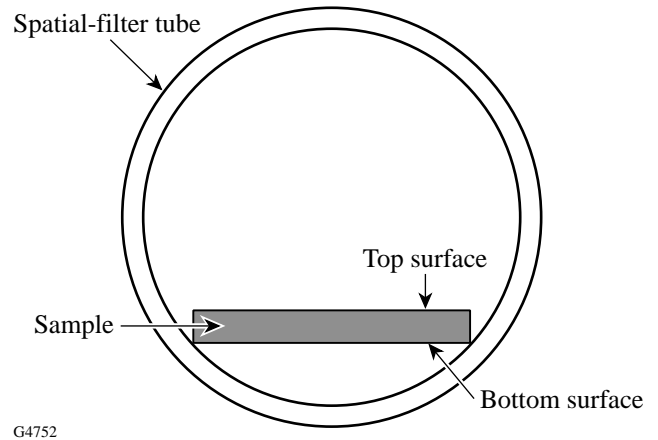
G4752

The results revealed that the spatial-filter tube’s cleanliness condition inflicts a stiff penalty, regardless of pinhole debris. As seen in Table 78.IX, all samples showed a significant drop in damage threshold after a two-months’ exposure to the

spatial-filter tube environment, and the top and bottom surface threshold data are virtually indistinguishable. The reported thresholds are 1-on-1 damage tests with a 1-mm² beam size; approximately 12 sites per sample were tested. Further SEM analysis revealed no high-Z element presence on the post-exposure surfaces, indicative of an absence of spatial-filter pinhole emanations on the top witness surface. It is difficult to predict the trajectory of ablated material, and further tests with samples located at various orientations are required to identify the path of ablated pinhole material that may contribute to lens damage. There is evidence on some pinholes that the edges are melted and craters have formed. While further experiments are needed to confirm pinhole ablation as an initiator for vacuum surface damage sites, the data confirm that oil contamination does decrease the sol-gel-coating damage threshold.

Figure 78.67
Witness sample orientation within a spatial-filter tube.
