In-Situ Detection and Analysis of Laser-Induced Damage on a 1.5-m Multilayer-Dielectric Grating Compressor for High-Energy, Petawatt-Class Laser Systems

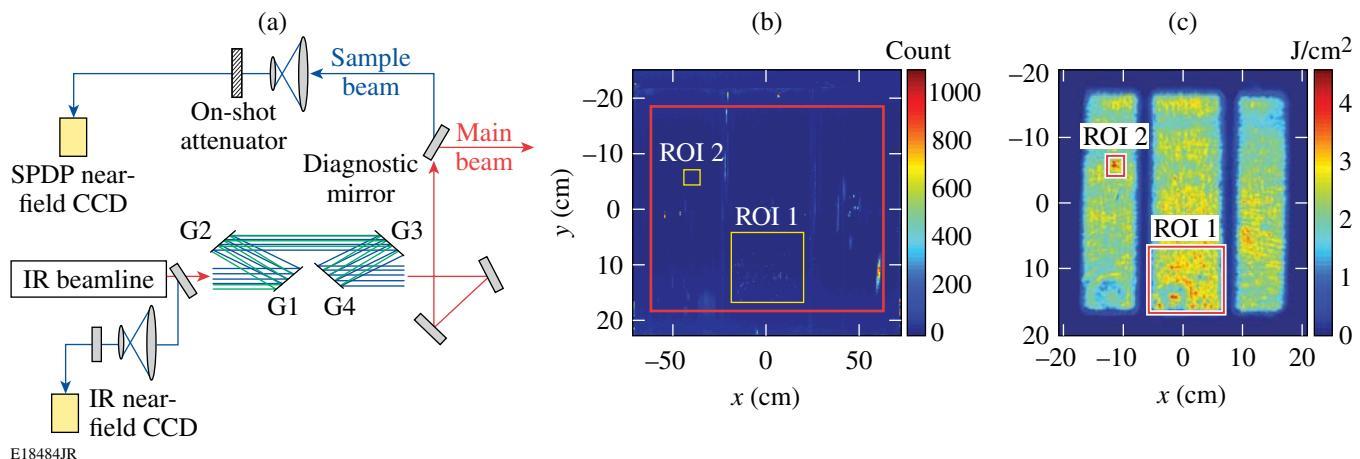
Figure 121.21

(a) The on-shot laser-fluence measurement path in relation to the grating compressor and the main-beam path; (b) a GIS image after the 2.2-kJ laser shot; (c) a beam-fluence map of the 2.2-kJ laser shot.

the holographic patterning of the gratings, and some existed prior to the energy ramp. Figure 121.21(c) shows the corresponding beam fluence measured on the 2.2-kJ shot. The main beam was shadowed along the gaps of the three individual tiles of grating 4. There is a factor of 0.3 scaling reduction in the *x* direction between Figs. 121.21(b) and 121.21(c). This is due to the 72.5° angle between the diagnostic beam and the normal of grating 4. Comparative analysis of the scanned images before and after each shot was used to assess any damage initiation and growth. By spatially registering the scanned image of the grating surface to the fluence map and by correlating the identified feature size and peak beam fluence within a specified ROI for each subsequent shot, the upper fluence limit below which damage growth occurred can be determined.

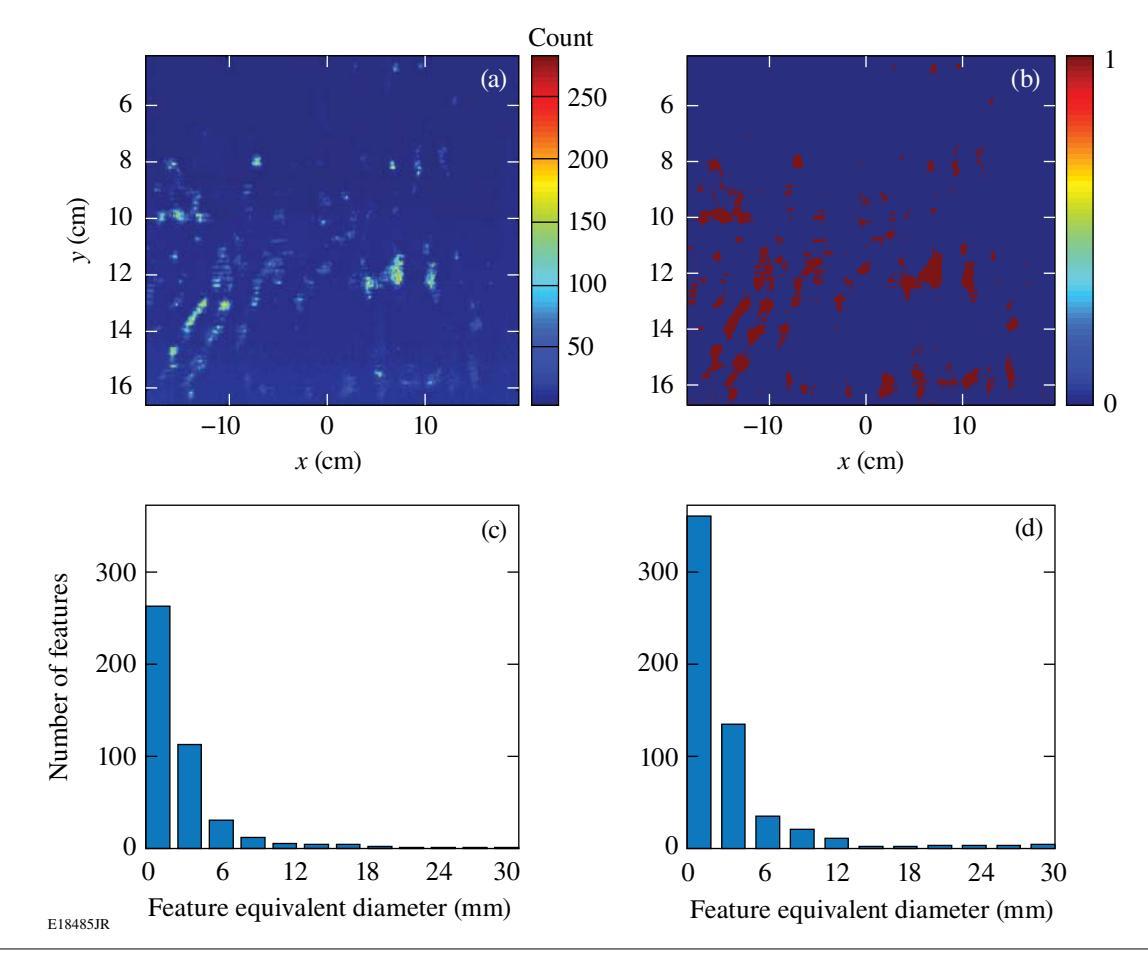
Figure 121.22

(a) Detected features in ROI 1 prior to the energy ramp; (b) binarized image of the detected features in ROI 1 prior to the energy ramp; (c) histogram of the detected features after the 1120-J shot; (d) histogram of the detected features after the 2210-J shot.

there are already a significant number of features in this ROI.) Figure 121.22(b) shows the corresponding binarized image of Fig. 121.22(a). Figures 121.22(c) and 121.22(d) illustrate the histograms of the detected features within ROI 1 prior to and after the energy ramp, respectively. Comparing histograms of damage sites of two consecutive shots, one can determine the shot energy that caused significant amounts of damage growth.

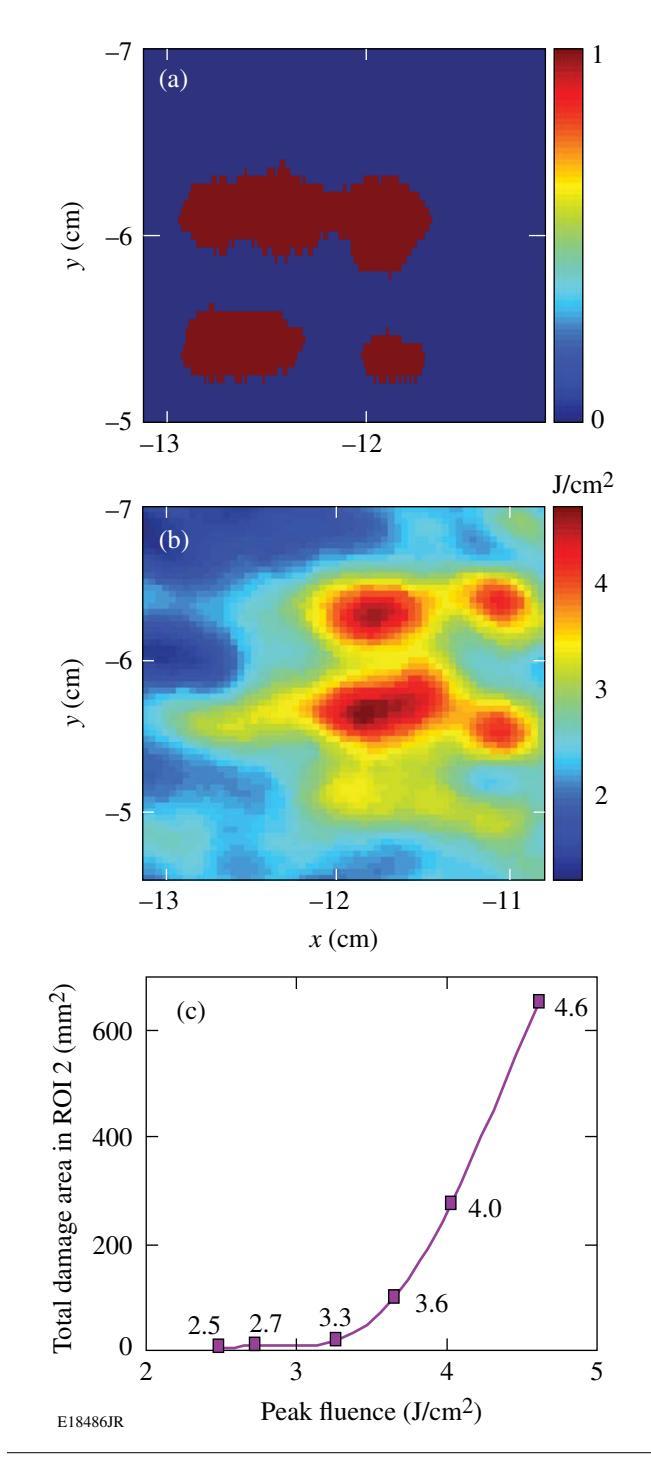
Figure 121.23

Owing to the fact that it is very challenging to register the grating-damage map and the beam-fluence map within high precision, the peak fluence within a ROI was used to estimate the upper limit of the fluence causing damage growth within that area. ROI 2 [also shown in Fig. 121.21(b)], measuring 23 mm \times 24 mm of grating 4, had no GIS-detectable features before the energy ramp and exhibited significant change after the completion of the energy ramp. This region was chosen to determine the upper limit of the incident fluence causing damage initiation and growth. The binarized scanning image, dimensions scaled to the laser-beam space, and the corresponding fluence map within ROI 2 for 2.2-kJ shot energy are shown in Figs. 121.23(a) and 121.23(b). The growth in damage versus peak fluence in ROI 2 is shown in Fig. 121.23(c). The fluence at which significant growth in damage occurred was determined to be 3.3 J/cm². This fluence was measured normal to the laser beam (72.5° relative to the grating normal). The corresponding shot energy was 1.58 kJ. The signal on the streak camera used for pulse measurement was saturated on this shot; therefore, no valid pulse measurement was obtained. Our on-shot pulseprediction model predicted a narrowed, 12.9-ps (FWHM intensity) pulse due to dispersion induced by nonlinear phase accumulations in the glass amplifiers.¹⁷ A similar analysis performed for ROI 1 showed a consistent result.

(a) Detected features in ROI 2 after the energy ramp; (b) fluence map of ROI 2 of the 2.2-kJ shot; (c) damage size versus beam fluence.

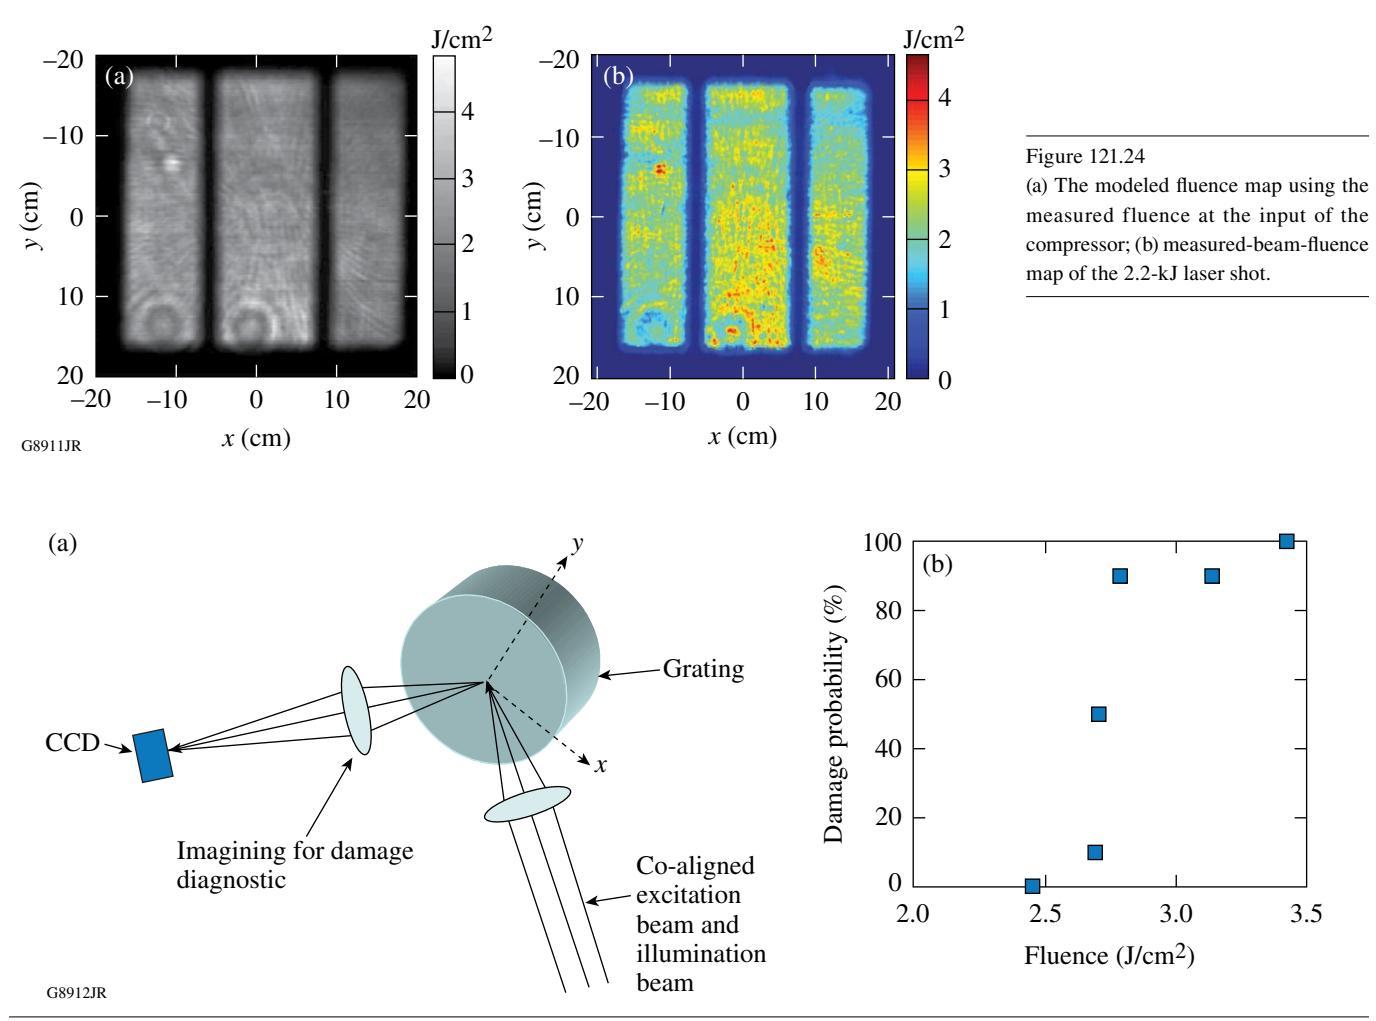
Figure 121.25

(a) Damage-test setup for damage probability at various beam fluences; (b) damage probability versus beam fluence measured on a 100-mm MLD-grating sample in vacuum.

damage probability. Figure 121.25(b) shows damage probability versus peak beam fluence. To compare with damage-test results of the large-aperture grating, the fluence was scaled to the beam space 72.5° relative to grating normal. As shown in Fig. 121.25(b), all ten sites under test were damaged at a fluence of 3.4 J/cm². This result is consistent with the determined fluence, where significant growth in damage occurred for a 12.9-ps pulse on large-scale gratings, taking into account that damage threshold scales approximately with the square root of the pulse length.¹⁸ This is the first damage test comparison between a small-sized witness sample and a large-scale grating. More tests will be conducted and results will be reported in a subsequent publication.
