**Characterization and Detection of the Deterioration of Electrical Connectors in a
Flash-lamp System**

LLE Advisors: Troy Walker and Greg Brent

Laboratory for Laser Energetics

Summer High School Research Program 2017

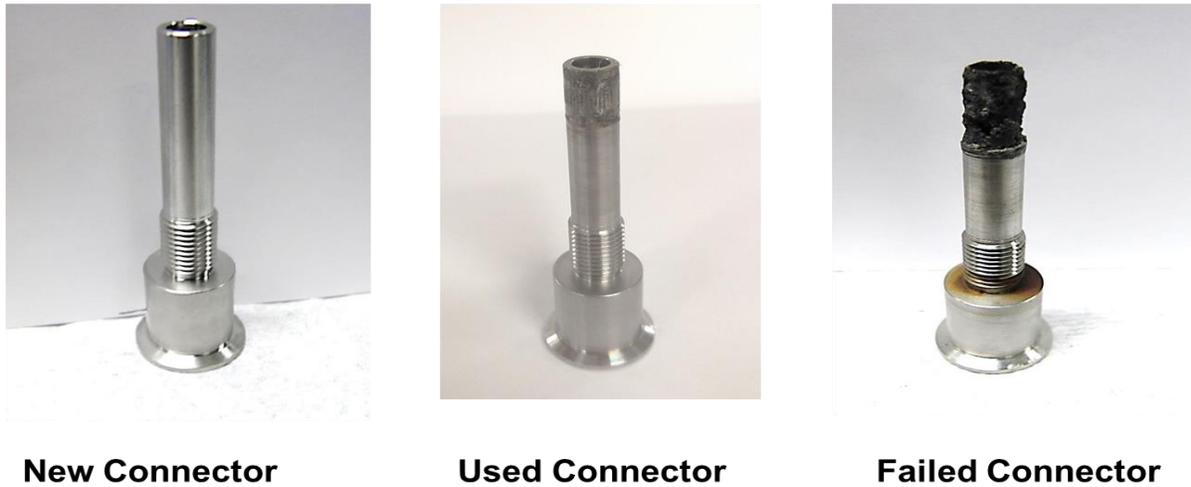
Figure 2: Progression of flash-lamp connectors from new, used, to failed.

In the 1990s, the Laboratory for Laser Energetics (LLE) Flash-lamp Test Facility was carrying out life expectancy testing on flash lamps to test the maximum number of shots the lamps could undergo before failure. Investigators observed that deionized water coming from the system momentarily dropped in resistance due to metal displacement from the connectors after each operation. Cleveland et al. provide data that supports this observation [1]. It was suspected that electrical arcing, as seen in Figure 1, caused this metal displacement in the connectors. The research described in this report aims to create a system to detect transient changes in water resistance and develop a method to characterize the properties of the changes. In turn, this characterization will assist lab operators in determining when maintenance is required on a flash-lamp system before an imminent failure occurs. A lab setup was developed to execute a proof of concept. This setup contained a deionized cooling-water system, a pulse forming network, and the flash-lamp system. Three flash-lamp systems were examined. Each had a different set of connectors. New (never used), slightly used (just burned-in but not worn-out), and used (ready to be replaced) sets of connectors were tested. Figure 2 shows connectors from a new set and a used set in comparison to a failed connector.

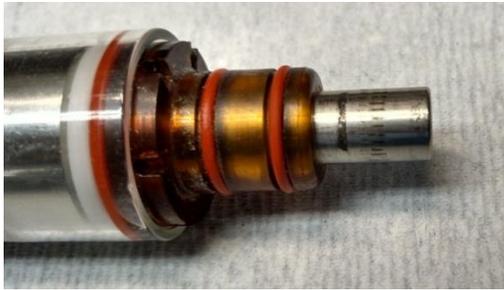
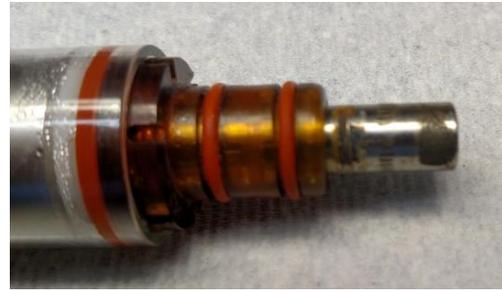
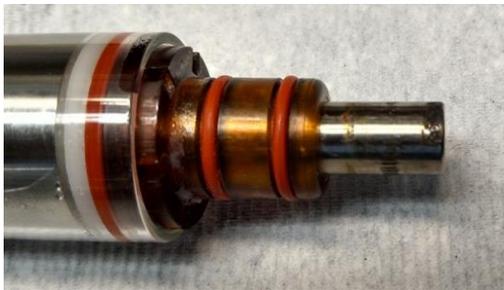
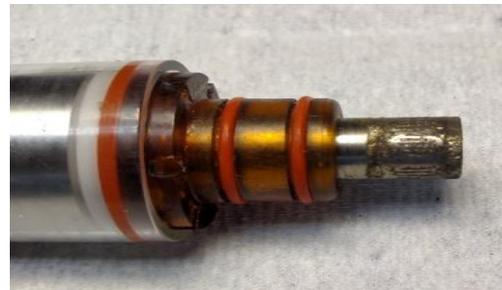
Figure 3: Side comparison of connectors used on the flash-lamp system. Figures 3(a) and 3(b) show the connector at one end of a flash lamp and Figures 3(c) and 3(d) the connector at the other end. Figures (a) and (c) view from the opposite side of (b) and (d).

Connectors were inspected after testing was completed. The connectors in Figure 3 are from a used set of connectors. For this set of connectors, alternate sides of the same connector displayed different degrees of deterioration. Figures 3(a) and 3(b) show opposite views of the connector at one end of a flash lamp. A large difference in the degree of deterioration is clearly seen. Opposite views of the connector at the other end (Figures 3(c) and 3(d)) show the same trend. This is caused by the flash-lamp system sitting horizontally, as has been demonstrated by the flash-

lamp maintenance team at LLE [2]. Varying degrees of deterioration on the same connector side are common on the OMEGA and OMEGA EP lasers at LLE.

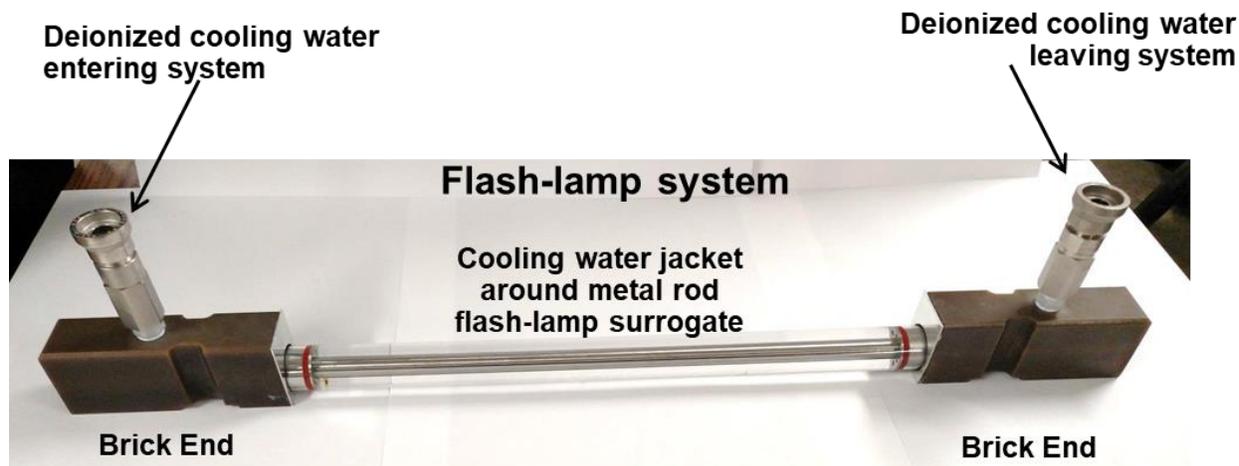
Figure 5: Modified flash-lamp system. The metal rod surrogate is between two brick ends from a 52" flash lamp. The flow of deionized cooling water through the system is shown.

The flash-lamp system contained the connectors that were tested. A modified flash-lamp setup (Fig. 5) was used to optimize the compactness of the proof-of-concept testing. Brick ends, where the connectors are housed, from 52” flash lamps were combined with a metal rod surrogate of 10” arc lamp distance. Figure 5 shows a metal rod used as a surrogate for an arc lamp on the modified setup to decrease the voltage required to reach the standard current simulating OMEGA and OMEGA EP laser flash-lamp operation.
