**Investigating the Causes of and Possible Remedies for Sensor Damage in Digital Cameras  
Used on the OMEGA Laser Systems**

Krysta Boccuzzi

**Our Lady of Mercy High School**  
Rochester, NY

**Laboratory for Laser Energetics**  
University of Rochester  
Rochester, NY

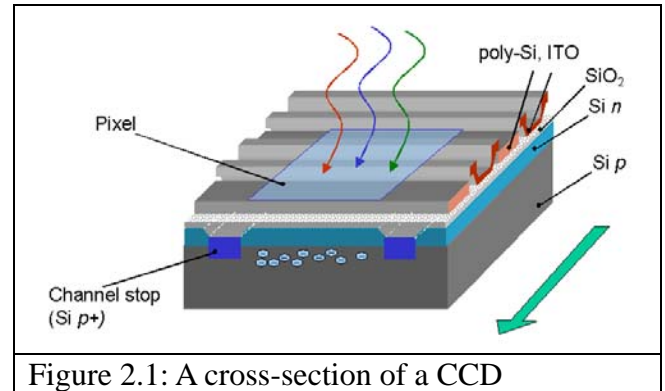
The damage to the CCD is caused mainly by neutron irradiation of the device. A CCD is composed of several layers of silicon, each layer including a different form of silicon. These layers can be seen in figure 2.1. Previous research has shown that neutrons with energy of 190 eV or greater can displace the

Figure 2.1: A cross-section of a CCD

silicon atoms from their lattice positions, creating trapping sites in the signal channel. This causes bulk damage, making it difficult for the information from the pixels to correctly reach the output node and resulting in low charge transfer efficiency.<sup>1</sup> Other research has yielded similar results.<sup>2,3</sup>
