# Damage Mechanisms in Multilayer Dielectric Gratings at Different Pulse Durations

B. N. Hoffman,<sup>1</sup> A. A. Kozlov,<sup>1</sup> N. Liu,<sup>2</sup> H. Huang,<sup>1</sup> J. B. Oliver,<sup>1</sup> A. L. Rigatti,<sup>1</sup> T. J. Kessler,<sup>1</sup> A. Shestopalov,<sup>1,2</sup> and S. G. Demos<sup>1</sup>

<sup>1</sup>Laboratory for Laser Energetics, University of Rochester

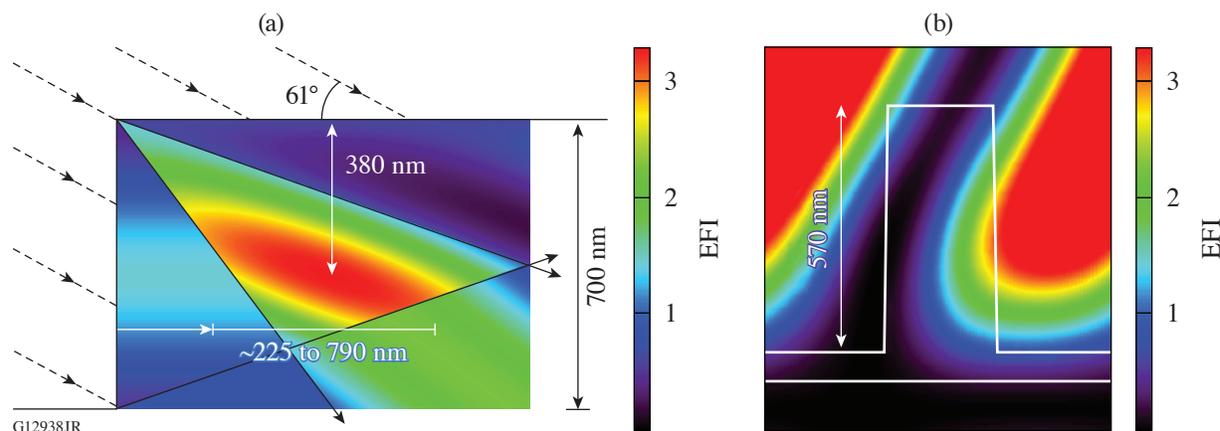
Figure 1

The grating-like structures were etched into a SiO<sub>2</sub> coating using processes similar to those used for MLD gratings. The grating-like structures are 700 nm in height, which is of the order of the MLD grating pillar height [see Fig. 1(a)]. The pillar height of the grating-like structures results in a 3× internal EFI enhancement factor, which is similar to that observed near the

The EFI enhancement (a) near the millimeter-pitch pillar wall region and (b) for the MLD grating design used in this work. The laser excitation is incident on the samples at a 61° angle from the left side.

right side of the MLD grating pillars [see Fig. 1(b)]. The grating-like structure and the MLD grating samples were damage tested in vacuum at 0.6 ps and 10 ps.
